## General Information

| Make | Toyota | Model | Hilux Tamaraw |

## Overall Evaluation :

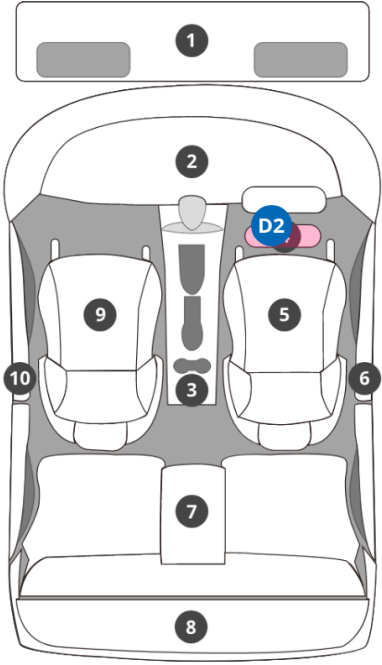
| Interior Evaluation : <span style="color: red;">A</span> | Exterior Evaluation : <span style="color: red;">E</span> |
| <b>Remarks</b><br>(L) Front Floor Mat - Worked - Small | <b>Remarks</b><br>(R) Guard Frame - Scratch & Dent - Large / (R) Side Gate - Scratch - Medium / Rear Bumper, Lamps, Panels - Scratch & Dent - Large / Cargo Bed Floor - Scratch & Dent - Large / Rear Gate - Scratch - Small / (L) Side Gate - Scratch - Medium / Roof - Scratch & Dent - Large / (L) Guard Frame - Scratch - Large / (L) Front Door, Molding - Scratch - Small / Front Bumper, Grille, Lamps - Scratch - Large / (R) Front Fender, Molding - Scratch - Small |

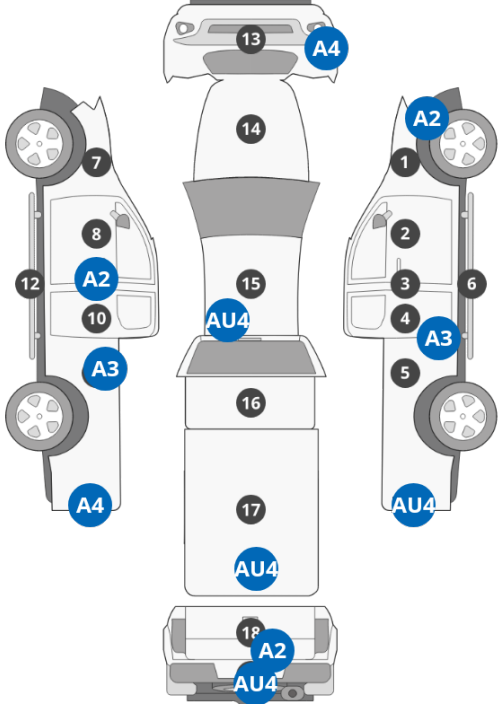
with maintenance warning light/ check engine light on/ possible flooding/ light scratches around the exterior/ no spare tire and jack/ no tools / with warranty booklet/ with LTO Plate/
