## General Information

| Make | Honda | Model | City |
| YOM | 2017 | Odo Meter Reading | 67,286 |
| Registration No. | NAV9116 | Chassis No. | PADGM66200HV308547 |

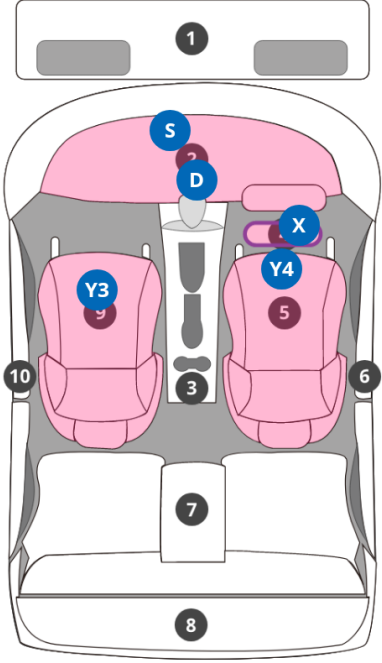
| Interior Evaluation : <b>C</b> | Exterior Evaluation : <b>E</b> |
| <p><b>Remarks</b></p> <p>Overall Interior - Smell - Yes / Overall Interior - Worn as per age - Yes / (R) Front Seat - Grime - Large / (L) Front Seat - Grime - Medium / Dashboard - Traces of Adhesive Tape - Yes / Mat Other - Missing - Yes</p> | <p><b>Remarks</b></p> <p>(R) Front Door - Repair Traces - Yes / (R) Step - Repair Traces - Yes / (R) Front Fender - Repair Traces - Yes / Bonnet - Repair Traces - Yes / (L) Front Fender - Repair Traces - Yes / (L) Front Door - Repair Traces - Yes / (L) Step - Repair Traces - Yes / (L) Rear Door - Repair Traces - Yes / (L) Rear Fender - Repair Traces - Yes / Trunk Hood, Rear Gate - Repair Traces - Yes / (R) Rear Door - Repair Traces - Yes / Roof - Repair Traces - Yes / (R) Front Door, Molding - Scratch &amp; Dent - Medium / (R) Rear Door, Molding - Scratch &amp; Dent - Large / (R) Rear Fender, Molding - Scratch &amp; Dent - Large / (R) Step, In-panel, Side Spoiler - Scratch &amp; Dent - Large / Rear Bumper, Lamps, Panels - Scratch &amp; Dent - Large / Trunk Hood, Rear Gate - Scratch &amp; Dent - Medium / (L) Rear Fender, Molding - Scratch - Small / (L) Rear Door, Molding - Dent - Small / (L) Front Door, Molding - Scratch &amp; Dent - Small / (L) Front Fender, Molding - Scratch - Medium / Front Bumper, Grille, Lamps - Scratch - Large / Bonnet, Headlight - Scratch - Large</p> |

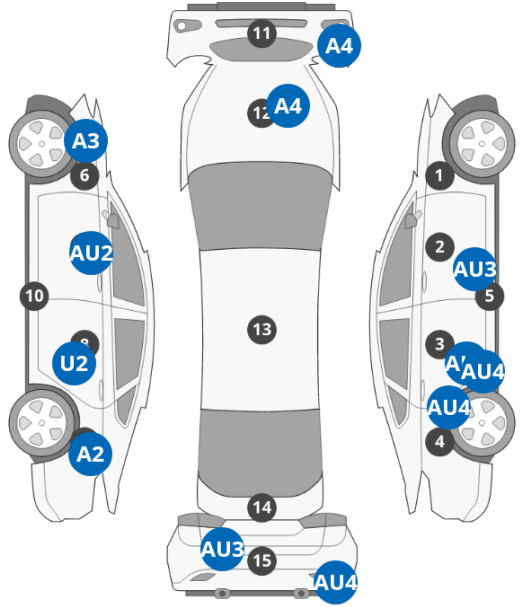
| Inspector Notes |
|---|
| no jack and tools/ light scratches around the exterior/ possible flooding/ with LTO Plate and warranty booklet/ with Spare tire/ |
