## General Information

| Make | Ford | Model | Everest |
| YOM | 2018 | Odo Meter Reading | 98,044 |

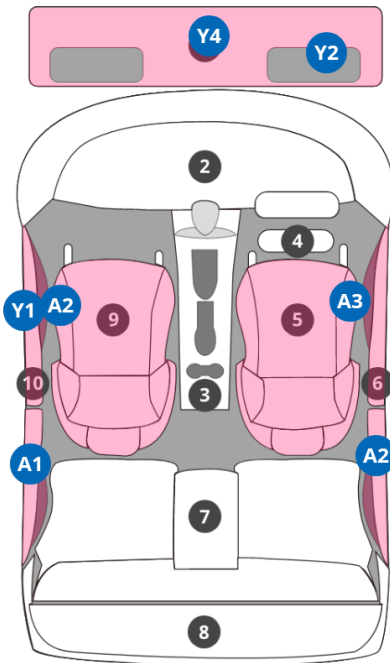
| Interior Evaluation : <span style="color: red;">C</span> | Exterior Evaluation : <span style="color: red;">E</span> |
|---|---|
| <p><b>Remarks</b><br/>Ceiling - Grime - Large / (R) Rear Trim - Cut, Crack - Small / (R) Front Seat - Cut, Crack - Medium / Sunvisor, Sunglass Holder - Grime - Small / (L) Front Trim - Grime - Minimal / (L) Front Seat - Cut, Crack - Small / (L) Rear Trim - Cut, Crack - Minimal</p> | <p><b>Remarks</b><br/>(R) Front Fender, Molding - Scratch &amp; Dent - Medium / (R) Mirror - Scratch - Minimal / (R) Front Door, Molding - Scratch &amp; Dent - Small / (R) Step, In-panel, Side Spoiler - Scratch - Medium / (R) Rear Door, Molding - Scratch - Small / (R) Rear Fender, Molding - Scratch - Minimal / Trunk Hood, Rear Gate - Scratch - Minimal / (L) Rear Fender, Molding - Scratch - Minimal / Roof - Rust, Corrosion - Medium / (L) Front Door, Molding - Scratch - Medium / (L) Front Fender, Molding - Scratch - Medium / Front Bumper, Grille, Lamps - Scratch - Large / Rear Bumper, Lamps, Panels - Scratch - Small / (L) Rear Door, Molding - Scratch - Minimal / Bonnet, Headlight - Scratch - Minimal / (L) Mirror - Scratch - Minimal / (L) Step, In-panel, Side Spoiler - Scratch - Small</p> |

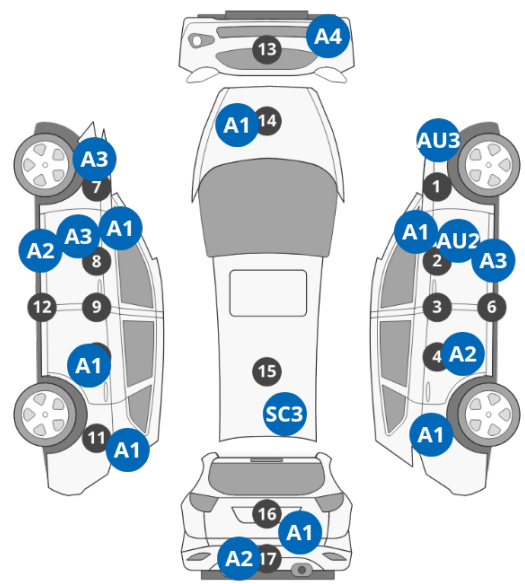
| Inspector Notes |
|---|
| With Lto plate, with spare tire, 1key, no warranty booklet and tools and Jack, scratches on headlights and taillights, Abnormal noise on engine, check engine warning lamp on |
