## General Information

| Make | Mitsubishi | Model | Mirage |
| YOM | 2024 | Odo Meter Reading | 36,370 |
| Registration No. | NKE4781 | Chassis No. | PAEA13TJRRRA029852 |

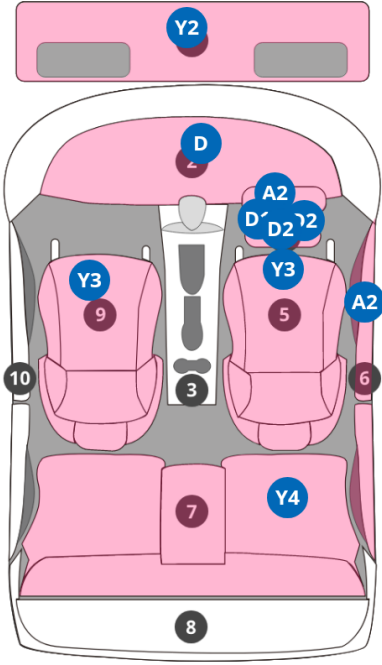
| Interior Evaluation : <span style="color: red; font-weight: bold;">C</span> | Exterior Evaluation : <span style="color: red; font-weight: bold;">E</span> |
|---|---|
| <b>Remarks</b><br>Ceiling - Grime - Small / Rear Seat - Grime - Large / (R) Front Seat - Grime - Medium / Dashboard - Traces of Adhesive Tape - Yes / (R) Front Floor Mat - Worked - Small / (R) Front Trim - Cut, Crack - Small / Glove Box - Worn, Scratch, Cut, Crack - Small / Mat Other - Grime - Small / (L) Front Seat - Grime - Medium / Carpet - Worked - Minimal / (L) Front Floor Mat - Worked - Small | <b>Remarks</b><br>(R) Front Fender, Molding - Scratch & Dent - Large / (R) Mirror - Scratch - Medium / (R) Front Door, Molding - Scratch - Small / (R) Rear Door, Molding - Scratch - Large / (R) Front Door, Molding - Scratch & Dent - Medium / (R) Step, In-panel, Side Spoiler - Scratch - Minimal / Rear Bumper, Lamps, Panels - Crack, Gap - Large / Trunk Hood, Rear Gate - Scratch & Dent - Large / (L) Rear Fender, Molding - Scratch & Dent - Medium / (L) Rear Door, Molding - Scratch - Small / (L) Step, In-panel, Side Spoiler - Scratch - Minimal / (L) Front Door, Molding - Scratch - Minimal / (L) Mirror - Scratch - Minimal / (L) Front Fender, Molding - Scratch - Medium / Front Bumper, Grille, Lamps - Scratch & Dent - Large / Bonnet, Headlight - Scratch - Small / Roof - Scratch - Small |

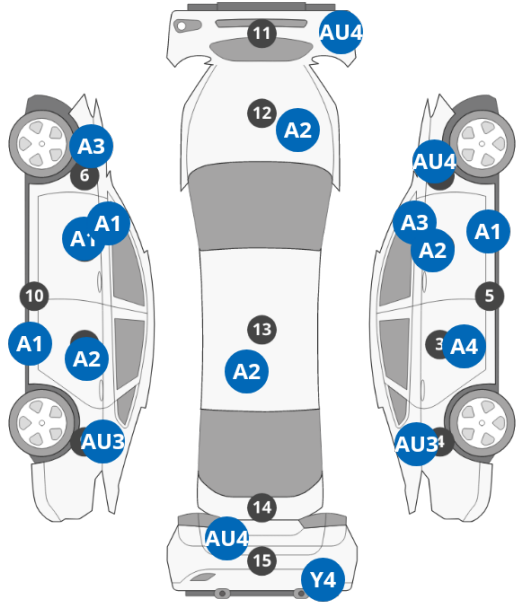
| Inspector Notes |
|---|
| With Lto plate, with spare tire and jack, 1key, no warranty booklet and tools, scratches on headlights, Crack taillight, latch trunk door issue |
