## General Information

| Make | Toyota | Model | Fortuner |
| Registration No. | APA2749 | Chassis No. | MHFZR69G603101658 |

## Body / Panel Condition

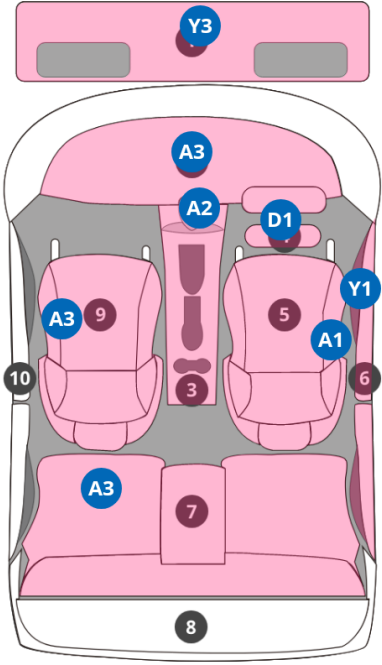
| Interior Evaluation : <span style="color: red;">C</span> | Exterior Evaluation : <span style="color: red;">E</span> |
| <b>Remarks</b><br>Ceiling - Grime - Medium / Rear Seat - Cut, Crack - Medium / (R) Front Trim - Grime - Minimal / (R) Front Seat - Cut, Crack - Minimal / (L) Front Seat - Cut, Crack - Medium / Console, Switchs, Vents - Worn, Scratch, Cut, Crack - Small / Carpet - Worked - Minimal / Steering Wheel - Worn, Peel, Crack - Medium | <b>Remarks</b><br>Trunk Hood, Rear Gate - Repair Traces - Yes / (R) Rear Door - Repair Traces - Yes / (R) Front Fender, Molding - Scratch - Minimal / (R) Mirror - Scratch - Minimal / (R) Front Door, Molding - Scratch & Dent - Large / (R) Step, In-panel, Side Spoiler - Scratch - Small / (R) Rear Door, Molding - Repair mark - Difference in Color / (R) Rear Door, Molding - Scratch - Small / Roof Spoiler, Molding - Scratch - Large / (R) Rear Fender, Molding - Scratch - Minimal / Rear Bumper, Lamps, Panels - Scratch & Dent - Medium / Trunk Hood, Rear Gate - Scratch - Small / (L) Rear Fender, Molding - Scratch - Small / (L) Rear Door, Molding - Scratch & Dent - Minimal / (L) Front Door, Molding - Scratch & Dent - Minimal / (L) Step, In-panel, Side Spoiler - Scratch - Small / (L) Mirror - Scratch - Small / (L) Front Fender, Molding - Scratch & Dent - Minimal / Front Bumper, Grille, Lamps - Scratch - Large |

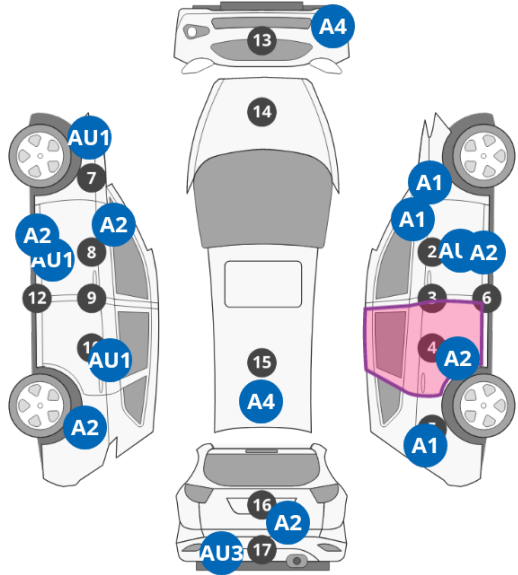
With Lto plate, with spare tire, 1key, no warranty booklet and tools and Jack, scratches on headlights and taillights, plate light issue, issue on radio button on steering wheel,
