## General Information

| Make | Toyota | Model | Vios |
| YOM | 2023 | Odo Meter Reading | 63,939 |

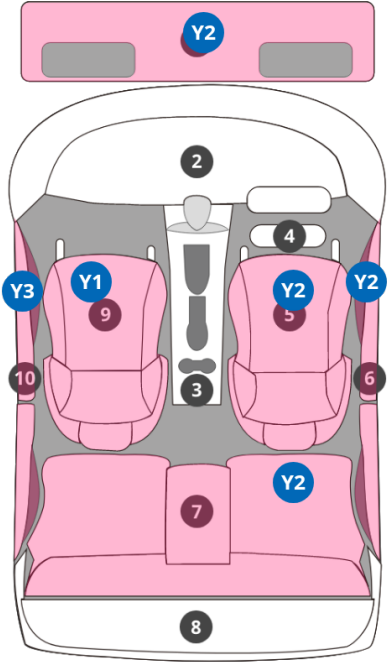
| Interior Evaluation : <b>B</b> | Exterior Evaluation : <b>E</b> |
| <b>Remarks</b><br>Ceiling - Grime - Small / Rear Seat - Grime - Small / (R) Front Trim - Grime - Small / (R) Front Seat - Grime - Small / (L) Front Trim - Grime - Medium / (L) Front Seat - Grime - Minimal | <b>Remarks</b><br>(R) Front Fender, Molding - Scratch - Medium / (R) Mirror - Scratch - Minimal / (R) Front Door, Molding - Scratch - Small / (R) Step, In-panel, Side Spoiler - Scratch - Minimal / (R) Rear Door, Molding - Scratch & Dent - Large / (R) Rear Fender, Molding - Scratch - Small / Rear Bumper, Lamps, Panels - Scratch & Dent - Large / Trunk Hood, Rear Gate - Scratch - Large / (L) Rear Fender, Molding - Scratch & Dent - Minimal / (L) Front Door, Molding - Scratch - Small / (L) Front Fender, Molding - Scratch - Minimal / Front Bumper, Grille, Lamps - Crack, Gap - Large / Bonnet, Headlight - Scratch - Small / (L) Step, In-panel, Side Spoiler - Scratch & Dent - Small / (L) Rear Door, Molding - Scratch - Minimal / Roof - Scratch - Minimal |
