## General Information

| Make | Toyota | Model | Vios |
| YOM | 2022 | Odo Meter Reading | 10,147 |
| Registration No. | CAX4414 | Chassis No. | PA1B18F32N4171858 |

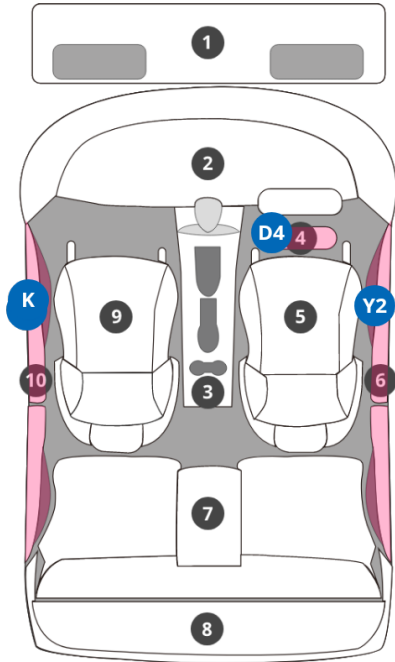
| Interior Evaluation : <span>C</span> | Exterior Evaluation : <span>D</span> |
| <b>Remarks</b><br>(L) Front Trim - Grime - Medium / (R) Front Trim - Grime - Small / Overall Interior - Animal Hair - Yes / (L) Front Floor Mat - Worked - Large | <b>Remarks</b><br>(R) Rear Door, Molding - Scratch & Dent - Large / (R) Front Door, Molding - Scratch & Dent - Small / (R) Rear Fender, Molding - Scratch - Small / (L) Rear Fender, Molding - Dent - Small / (L) Rear Door, Molding - Dent - Small / Rear Bumper, Lamps, Panels - Scratch - Medium / Bonnet, Headlight - Scratch - Large / Overall Exterior - Faded(Color, Gloss) - Yes / Front Bumper, Grille, Lamps - Scratch - Small / (R) Front Fender, Molding - Scratch - Small / Trunk Hood, Rear Gate - Scratch - Small / (L) Front Door, Molding - Scratch - Small / (L) Front Fender, Molding - Scratch - Minimal |

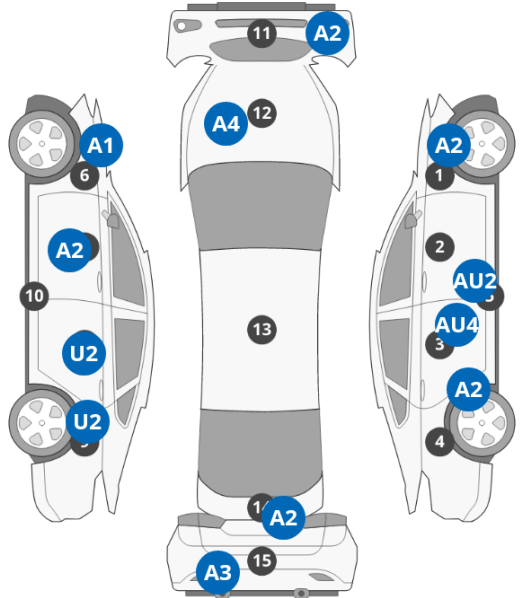
possible flooding/ windshield issue/no warranty booklet and Incomplete tools/ light scratches around the exterior/ with LTO Plate and spare tire/
