## General Information

| Make | Toyota | Model | Vios |

## Body / Panel Condition

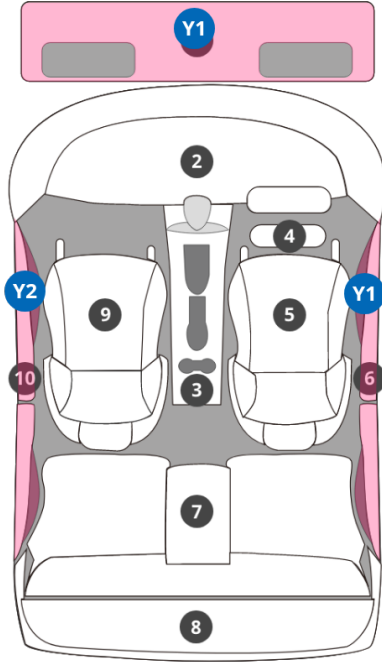
| Interior Evaluation : <b>A</b> | Exterior Evaluation : <b>C</b> |
| <p><b>Remarks</b><br/>Ceiling - Grime - Minimal / (R) Front Trim - Grime - Minimal / (L) Front Trim - Grime - Small</p> | <p><b>Remarks</b><br/>(R) Front Fender, Molding - Scratch - Minimal / (R) Mirror - Scratch - Minimal / (R) Front Door, Molding - Scratch - Medium / (R) Rear Door, Molding - Scratch - Minimal / (R) Step, In-panel, Side Spoiler - Scratch - Medium / (R) Rear Fender, Molding - Scratch &amp; Dent - Minimal / Rear Bumper, Lamps, Panels - Scratch - Small / Trunk Hood, Rear Gate - Scratch - Minimal / (L) Rear Fender, Molding - Scratch - Minimal / (L) Rear Door, Molding - Scratch - Minimal / (L) Front Door, Molding - Scratch - Minimal / (L) Step, In-panel, Side Spoiler - Scratch - Minimal / (L) Mirror - Scratch - Minimal / (L) Front Fender, Molding - Scratch - Minimal / Front Bumper, Grille, Lamps - Scratch - Medium / Bonnet, Headlight - Scratch - Minimal</p> |

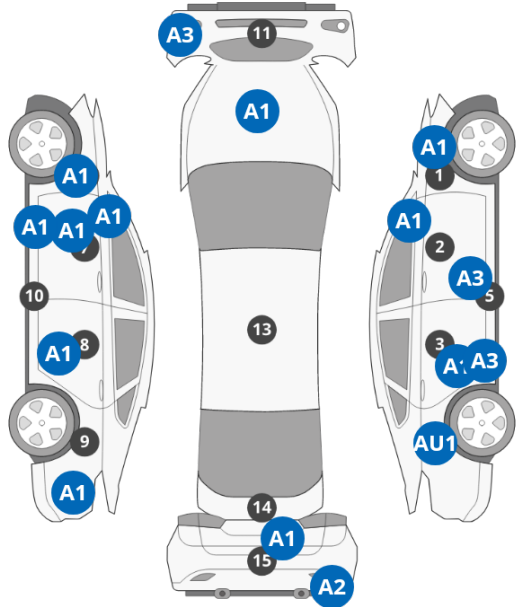
With Lto plate, with spare tire and tools and Jack, 1key, no warranty booklet, scratches on headlights and taillights, plate light issue, left fender light issue
