## General Information

| Make | Toyota | Model | Wigo |
| YOM | 2025 | Odo Meter Reading | 18,021 |

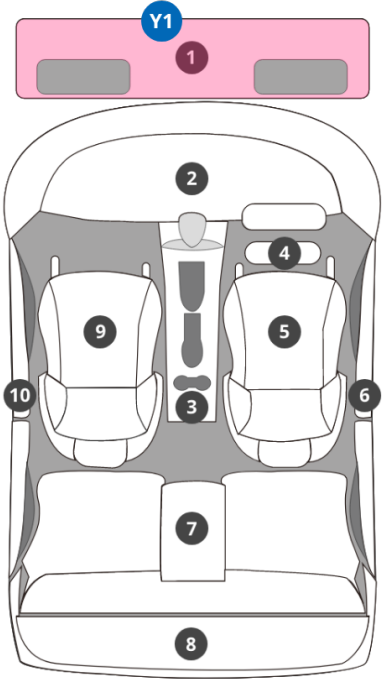
| Interior Evaluation : <b>A</b> | Exterior Evaluation : <b>B</b> |
| <b>Remarks</b><br>Ceiling - Grime - Minimal | <b>Remarks</b><br>Front Bumper, Grille, Lamps - Scratch & Dent - Medium / Rear Bumper, Lamps, Panels - Scratch - Small / (L) Rear Fender, Molding - Scratch - Minimal / (L) Rear Door, Molding - Scratch - Minimal / (L) Front Door, Molding - Scratch - Minimal / (L) Front Fender, Molding - Scratch - Medium |

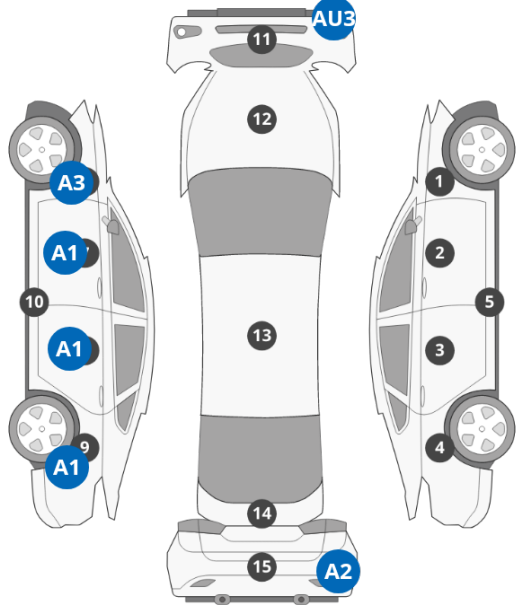
with lto plate, with spare tire, with jack, incomplete tools, hairline scratches in the body, 1 spare key
