## General Information

| Make | Toyota | Model | Vios |
| YOM | 2023 | Odo Meter Reading | 46,458 |

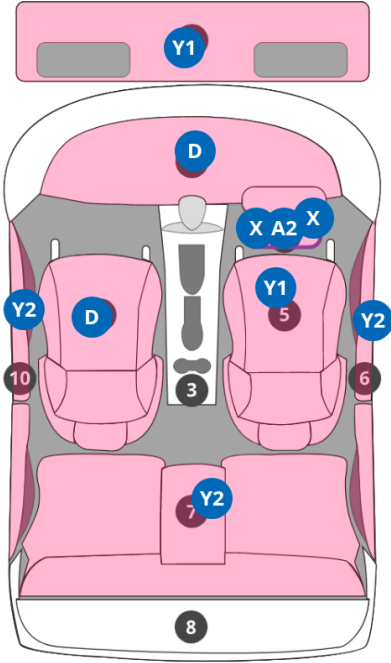
| Interior Evaluation : <b>B</b> | Exterior Evaluation : <b>D</b> |
|---|---|
| <p><b>Remarks</b></p> <p>Rear Seat - Grime - Small / (R) Front Trim - Grime - Small / (R) Front Seat - Grime - Minimal / (R) Front Floor Mat - Missing - Yes / (L) Front Floor Mat - Missing - Yes / (L) Front Trim - Grime - Small / (L) Front Seat - Worn - Yes / Ceiling - Grime - Minimal / Dashboard - Traces of Adhesive Tape - Yes / Carpet - Worn, Scratch, Cut, Crack - Small</p> | <p><b>Remarks</b></p> <p>(L) Front Fender, Molding - Scratch - Minimal / (L) Front Door, Molding - Scratch - Small / (L) Step, In-panel, Side Spoiler - Scratch - Small / (L) Rear Door, Molding - Scratch - Minimal / (L) Rear Fender, Molding - Scratch - Minimal / Rear Bumper, Lamps, Panels - Scratch - Medium / Trunk Hood, Rear Gate - Scratch &amp; Dent - Medium / (R) Rear Fender, Molding - Scratch - Small / (R) Rear Door, Molding - Scratch - Medium / (R) Step, In-panel, Side Spoiler - Scratch &amp; Dent - Large / (R) Front Door, Molding - Scratch - Medium / (R) Mirror - Scratch - Minimal / (R) Front Fender, Molding - Scratch - Minimal / Bonnet, Headlight - Scratch - Minimal / Front Bumper, Grille, Lamps - Scratch - Medium / Roof - Scratch - Minimal</p> |
