## General Information

| Make | Toyota | Model | Wigo |
| YOM | 2023 | Odo Meter Reading | 103,165 |
| Registration No. | NHJ2103 | Chassis No. | MHKA4DF5FPJ080225 |

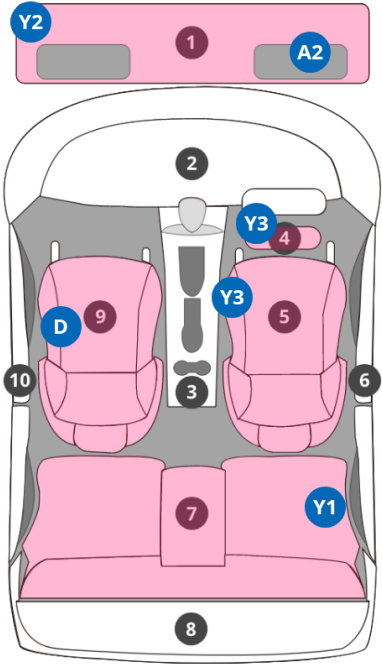
| Interior Evaluation : <b>C</b> | Exterior Evaluation : <b>E</b> |
|---|---|
| <b>Remarks</b><br>(L) Front Floor Mat - Grime - Medium / (R) Front Seat - Grime - Medium / (L) Front Seat - Worn - Yes / Overall Interior - Worn as per age - Yes / Ceiling - Grime - Small / Rear Seat - Grime - Minimal / Sunvisor, Sunglass Holder - Cut, Crack - Small | <b>Remarks</b><br>(R) Front Fender, Molding - Dent - Small / (R) Mirror - Scratch - Small / (R) Front Door, Molding - Scratch & Dent - Medium / Rear Bumper, Lamps, Panels - Repair mark - Yes / (R) Rear Door, Molding - Scratch - Medium / (R) Step, In-panel, Side Spoiler - Scratch & Dent - Small / Rear Bumper, Lamps, Panels - Crack, Gap - Medium / Trunk Hood, Rear Gate - Scratch - Minimal / (L) Rear Fender, Molding - Scratch & Dent - Large / (L) Rear Door, Molding - Scratch & Dent - Large / (L) Front Door, Molding - Scratch & Dent - Large / (L) Front Fender, Molding - Scratch & Dent - Large / (L) Mirror - Scratch - Small / Front Bumper, Grille, Lamps - Scratch & Dent - Large / Bonnet, Headlight - Scratch - Minimal / Roof - Scratch - Minimal |

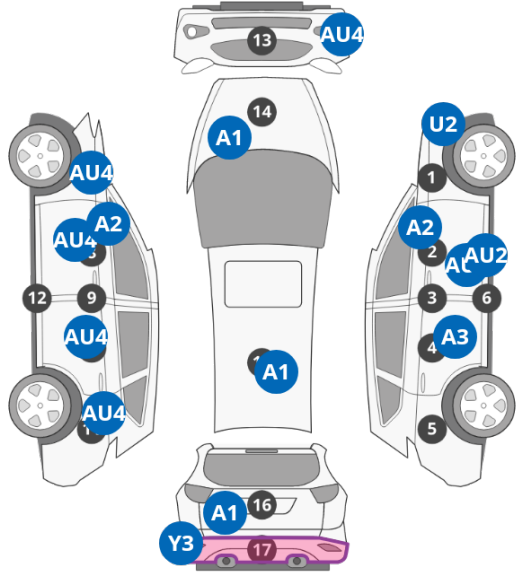
| Inspector Notes |
|---|
| with warranty booklet, no jack and tools, with spare tire, with LTO plate, scratches on tail light, fog lamp issue, front right support grab bar missing |
