## General Information

| Make | Toyota | Model | Wigo |
| YOM | 2024 | Odo Meter Reading | 49,022 |

## Body / Panel Condition

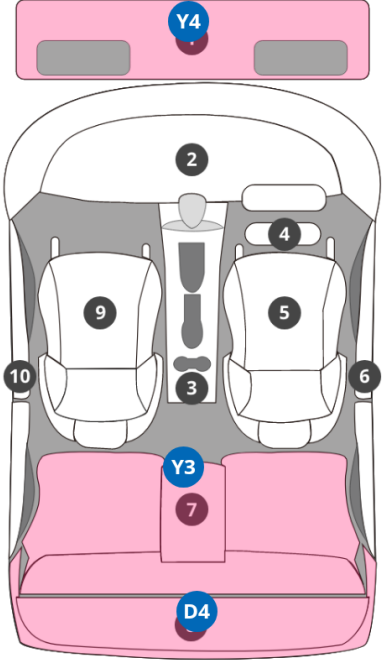
| Interior Evaluation : <b>C</b> | Exterior Evaluation : <b>C</b> |
| <p><b>Remarks</b><br/>Ceiling - Grime - Large / Rear Seat - Grime - Medium / Trunk Room - Worked - Large</p> | <p><b>Remarks</b><br/>(R) Front Door - Repair Traces - Yes / Bonnet - Repair Traces - Yes / (L) Rear Fender - Repair Traces - Yes / Trunk Hood, Rear Gate - Repair Traces - Yes / Roof - Repair Traces - Yes / (R) Mirror - Scratch, Peeled - Minimal / (R) Rear Door, Molding - Scratch - Minimal / (R) Front Door, Molding - Scratch - Large / Trunk Hood, Rear Gate - Repair mark - Yes / (L) Rear Fender, Molding - Repair mark - Yes / (L) Rear Door, Molding - Repair mark - Yes / (L) Front Fender, Molding - Scratch &amp; Dent - Small / Bonnet, Headlight - Dent - Small / Front Bumper, Grille, Lamps - Repair mark - Difference in Color</p> |
