## General Information

| Make | Toyota | Model | Vios |
| YOM | 2025 | Odo Meter Reading | 4,968 |

## Body / Panel Condition

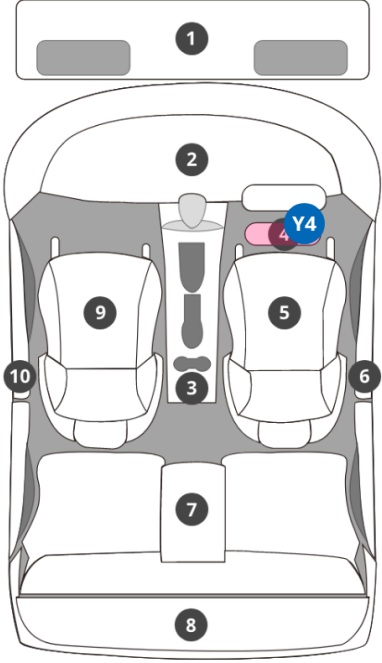
| Interior Evaluation : <span style="color: red;">C</span> | Exterior Evaluation : <span style="color: red;">B</span> |
| <b>Remarks</b><br>Mat Other - Grime - Large | <b>Remarks</b><br>(R) Front Door, Molding - Scratch - Minimal / (R) Front Fender, Molding - Scratch - Minimal / (R) Rear Door, Molding - Scratch - Small / Trunk Hood, Rear Gate - Scratch - Medium / (L) Rear Door, Molding - Scratch - Small / (L) Front Door, Molding - Scratch - Minimal / (L) Front Fender, Molding - Scratch - Medium / Front Bumper, Grille, Lamps - Scratch & Dent - Small / (L) Mirror - Scratch - Minimal |

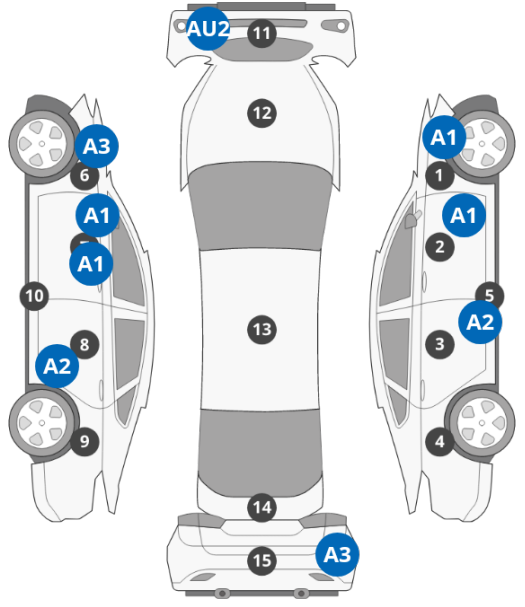
with Ito plate, no warranty booklet, with spare tire, with jack, with tools, with hairline scratches in the body
