## General Information

| Make | Toyota | Model | Hilux Tamaraw |

## Body / Panel Condition

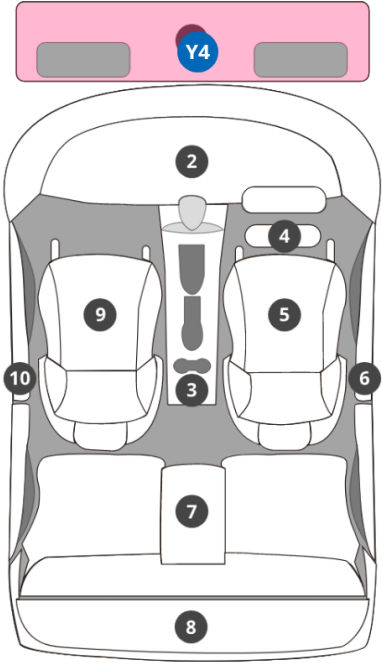
| Interior Evaluation : <span style="color: red;">C</span> | Exterior Evaluation : <span style="color: red;">E</span> |
| <b>Remarks</b><br>Ceiling - Grime - Large | <b>Remarks</b><br>(R) Front Door, Molding - Scratch & Dent - Large / (R) Step, In-panel, Side Spoiler - Scratch & Dent - Large / (R) Guard Frame - Repair mark - Yes / (R) Guard Frame - Scratch & Dent - Medium / Rear Gate - Scratch & Dent - Medium / (L) Guard Frame - Crack, Gap - Medium / (L) Guard Frame - Repair mark - Yes / (L) Front Door, Molding - Scratch - Minimal / Front Bumper, Grille, Lamps - Scratch - Small / Roof - Scratch - Small / Roof - Repair mark - Yes / Cargo Bed Floor - Scratch - Large |
