## General Information

| Make | Toyota | Model | Vios |

## Body / Panel Condition

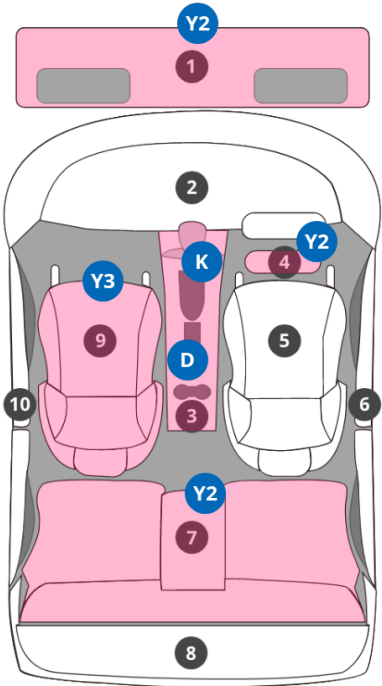
| Interior Evaluation : <b>B</b> | Exterior Evaluation : <b>B</b> |
|---|---|
| <p><b>a</b> : Cut, Fray <b>d</b> : Loose, Deformed <b>k</b> : Animal Hair <b>s</b> : Smell <b>t</b> : Cigarette Burns <b>x</b> : Defective <b>y</b> : Stain</p> | <p><b>A</b> : Scratch <b>AU</b> : Scratch &amp; Dent <b>B</b> : Modified <b>C</b> : Corrosion <b>G</b> : Stone chip <b>P</b> : Faded <b>S</b> : Rust <b>SC</b> : Rust &amp; Corrosion <b>U</b> : Dent <b>X</b> : Defective <b>Y</b> : Crack, Gap</p> |
| <p><b>Remarks</b></p> <p>Overall Interior - Animal Hair - Yes / (L) Front Seat - Grime - Medium / Mat Other - Grime - Small / Rear Seat - Grime - Small / Ceiling - Grime - Small / Console, Switchs, Vents - Traces of Adhesive Tape - Yes</p> | <p><b>Remarks</b></p> <p>(R) Front Fender, Molding - Scratch - Small / (R) Front Door, Molding - Scratch &amp; Dent - Medium / (L) Front Door, Molding - Scratch &amp; Dent - Small / Front Bumper, Grille, Lamps - Scratch - Medium / Roof - Dent - Small</p> |
