## General Information

| Make | Toyota | Model | Vios |

## Body / Panel Condition

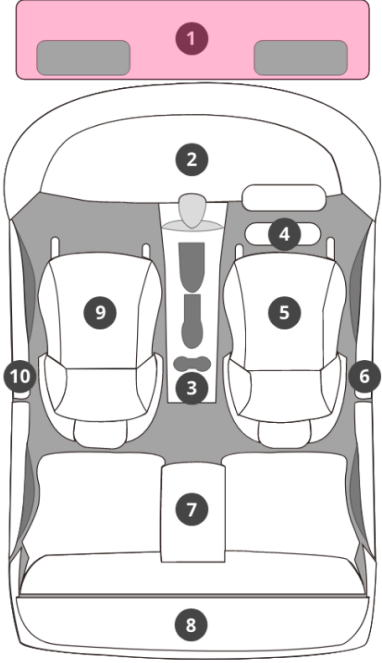
| Interior Evaluation : <b>A</b> | Exterior Evaluation : <b>B</b> |
| <b>Remarks</b><br>Defects not found | <b>Remarks</b><br>(L) Rear Fender - Repair Traces - Yes / (R) Mirror - Scratch, Peeled - Minimal / Rear Bumper, Lamps, Panels - Scratch - Medium / Front Bumper, Grille, Lamps - Scratch - Small |
