## General Information

| Make | Toyota | Model | Vios |
| Registration No. | NHR6887 | Chassis No. | PA1B18F30P4232045 |

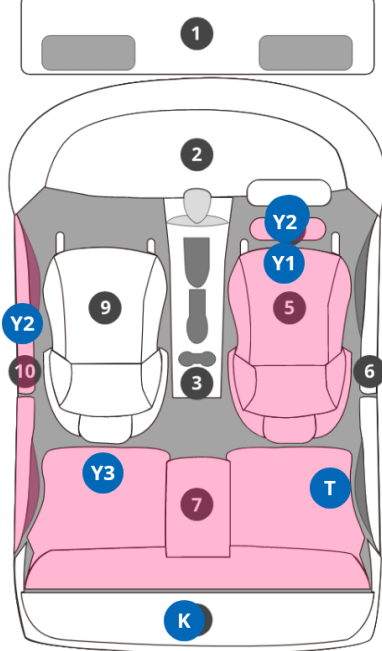
| Interior Evaluation : <span style="color: red;">C</span> | Exterior Evaluation : <span style="color: red;">D</span> |
| <b>Remarks</b><br>Overall Interior - Animal Hair - Yes / Rear Seat - Cigarette Burns - Burnt, Hole / Rear Seat - Grime - Medium / (R) Front Seat - Grime - Minimal / (L) Front Trim - Grime - Small / (L) Front Floor Mat - Worked - Small / Mat Other - Grime - Medium / (R) Front Floor Mat - Grime - Small | <b>Remarks</b><br>(R) Front Door - Repair Traces - Yes / (R) Front Fender - Repair Traces - Yes / Bonnet - Repair Traces - Yes / (R) Rear Fender - Repair Traces - Yes / (R) Rear Door - Repair Traces - Yes / (R) Front Fender, Molding - Scratch & Dent - Medium / (R) Front Door, Molding - Scratch & Dent - Large / (R) Rear Door, Molding - Scratch - Small / Trunk Hood, Rear Gate - Scratch - Small / Rear Bumper, Lamps, Panels - Repair mark - Yes / Rear Bumper, Lamps, Panels - Scratch - Medium / (L) Front Door, Molding - Scratch - Small / (L) Rear Door, Molding - Scratch - Minimal / Front Bumper, Grille, Lamps - Scratch & Dent - Large / (R) Mirror - Scratch - Minimal / (L) Rear Fender, Molding - Scratch - Minimal / Member (Bolted) - Dent - Yes / Bonnet, Headlight - Scratch - Small |
