## General Information

| Make | Toyota | Model | Vios |
| YOM | 2022 | Odo Meter Reading | 169,528 |
| Registration No. | NFE6794 | Chassis No. | PA1B18F39N4187474 |

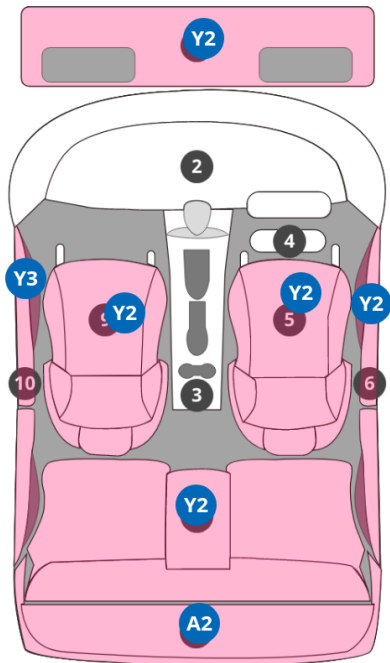
| Interior Evaluation : <b>B</b> | Exterior Evaluation : <b>E</b> |
|---|---|
| <b>Remarks</b><br>Rear Seat - Grime - Small / (R) Front Trim - Grime - Small / (R) Front Seat - Grime - Small / Trunk Room - Worn, Scratch, Cut, Crack - Small / (L) Front Trim - Grime - Medium / Ceiling - Grime - Small / (L) Front Seat - Grime - Small | <b>Remarks</b><br>(R) Front Door - Repair Traces - Yes / (R) Front Fender - Repair Traces - Yes / Bonnet - Repair Traces - Yes / (L) Front Fender - Repair Traces - Yes / (L) Front Door - Repair Traces - Yes / (L) Rear Door - Repair Traces - Yes / (L) Rear Fender - Repair Traces - Yes / Trunk Hood, Rear Gate - Repair Traces - Yes / (R) Rear Door - Repair Traces - Yes / Roof - Repair Traces - Yes / Member (Bolted) - Dent - Yes / (L) Mirror - Scratch - Minimal / (L) Front Fender, Molding - Repair mark - Yes / Bonnet, Headlight - Repair mark - Yes / (R) Front Fender, Molding - Repair mark - Yes / (R) Rear Door, Molding - Repair mark - Yes / Front Bumper, Grille, Lamps - Scratch - Small / (L) Front Door, Molding - Scratch - Small / (L) Rear Door, Molding - Scratch & Dent - Small / Roof - Scratch & Dent - Small / (L) Rear Fender, Molding - Scratch - Small / Trunk Hood, Rear Gate - Scratch & Dent - Medium / Rear Bumper, Lamps, Panels - Scratch - Medium / (R) Rear Fender, Molding - Dent - Small / (R) Rear Door, Molding - Dent - Small / (R) Mirror - Scratch - Minimal / (R) Front Door, Molding - Scratch & Dent - Small / (L) Front Fender, Molding - Crack, Gap - Medium / Bonnet, Headlight - Scratch - Small / (R) Front Fender, Molding - Scratch - Small |
