## General Information

| Make | Toyota | Model | Vios |

## Body / Panel Condition

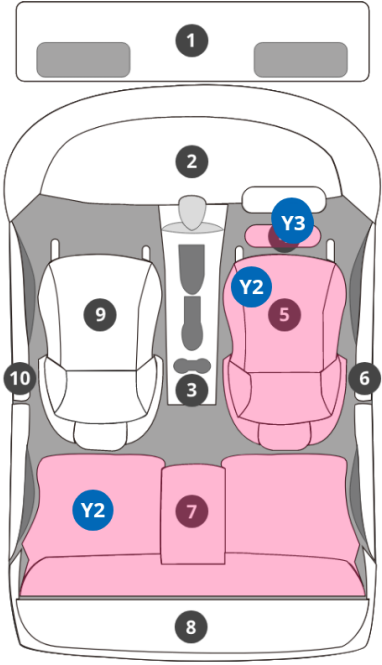
| Interior Evaluation : <b>B</b> | Exterior Evaluation : <b>C</b> |
| <b>Remarks</b><br>(L) Front Floor Mat - Grime - Medium / Rear Seat - Grime - Small / (R) Front Seat - Grime - Small / (R) Front Floor Mat - Grime - Medium | <b>Remarks</b><br>(R) Rear Fender, Molding - Scratch - Minimal / Rear Bumper, Lamps, Panels - Dent - Small / Trunk Hood, Rear Gate - Dent - Small / (L) Mirror - Scratch - Minimal / Front Bumper, Grille, Lamps - Crack, Gap - Large / (R) Front Fender, Molding - Scratch - Minimal / (R) Mirror - Scratch - Minimal / Roof - Dent - Small / (L) Front Door, Molding - Scratch - Medium / (L) Rear Door, Molding - Scratch - Small / (R) Rear Door, Molding - Scratch - Small |
