## General Information

| Make | Toyota | Model | Avanza |
| Registration No. | CCA3120 | Chassis No. | MHFAA1BY0P0017938 |

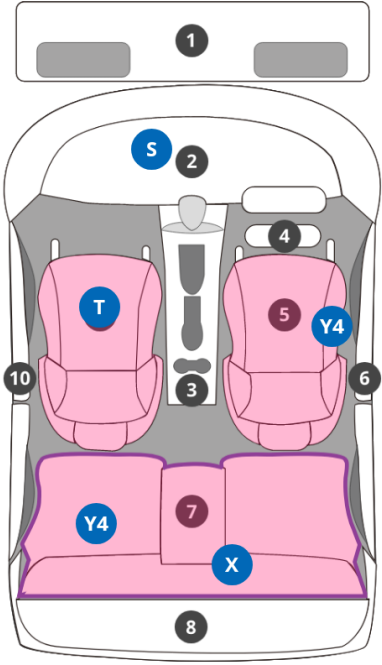
| Interior Evaluation : <span style="color: red;">C</span> | Exterior Evaluation : <span style="color: red;">E</span> |
| <b>Remarks</b><br>Overall Interior - Smell - Yes / (L) Front Seat - Cigarette Burns - Burnt, Hole / Rear Seat - Grime - Large / Rear Seat - Partially Missing - Yes / (R) Front Seat - Grime - Large | <b>Remarks</b><br>Front Bumper, Grille, Lamps - Scratch & Dent - Large / (L) Front Fender, Molding - Scratch & Dent - Large / (L) Front Door, Molding - Scratch - Large / (L) Rear Door, Molding - Scratch - Large / (L) Rear Fender, Molding - Scratch & Dent - Small / Rear Bumper, Lamps, Panels - Scratch & Dent - Medium / Trunk Hood, Rear Gate - Scratch - Medium / (R) Rear Door, Molding - Dent - Small / (R) Front Fender, Molding - Dent - Small / Roof - Dent - Medium / Bonnet, Headlight - Scratch - Small / (R) Front Door, Molding - Scratch - Small |
