## General Information

| Make | Mitsubishi | Model | Mirage |

## Body / Panel Condition

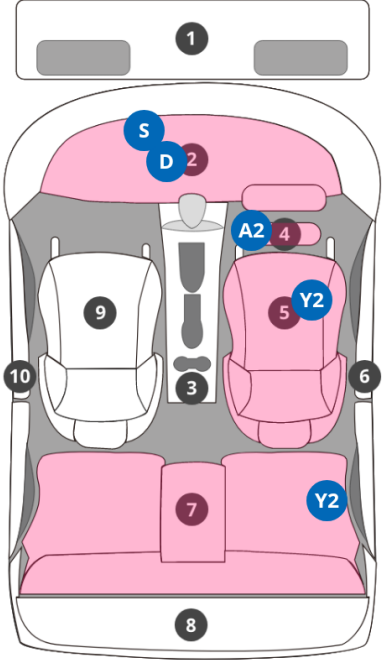
| Interior Evaluation : <b>B</b> | Exterior Evaluation : <b>E</b> |
| <b>Remarks</b><br>Dashboard - Traces of Adhesive Tape - Yes / (R) Front Seat - Grime - Small / (L) Front Floor Mat - Cut, Crack - Small / Rear Seat - Grime - Small / Overall Interior - Smell - Yes | <b>Remarks</b><br>(L) Front Fender - Repair Traces - Yes / (L) Front Door - Repair Traces - Yes / (L) Rear Door - Repair Traces - Yes / Rear Bumper, Lamps, Panels - Scratch & Dent - Large / (R) Rear Fender, Molding - Dent - Small / (R) Rear Door, Molding - Scratch - Large / Front Bumper, Grille, Lamps - Scratch & Dent - Large / (R) Front Door, Molding - Scratch - Small / Bonnet, Headlight - Scratch - Small / (L) Front Fender, Molding - Dent - Small / (L) Front Door, Molding - Scratch & Dent - Large / (L) Rear Door, Molding - Scratch & Dent - Small / (L) Rear Fender, Molding - Scratch & Dent - Small / Trunk Hood, Rear Gate - Scratch - Small / Roof - Dent - Small |
