## General Information

| Make | Ford | Model | Ranger |
| YOM | 2020 | Odo Meter Reading | 105,216 |
| Registration No. | NEG6483 | Chassis No. | MNCUMFF40KW0237080 |

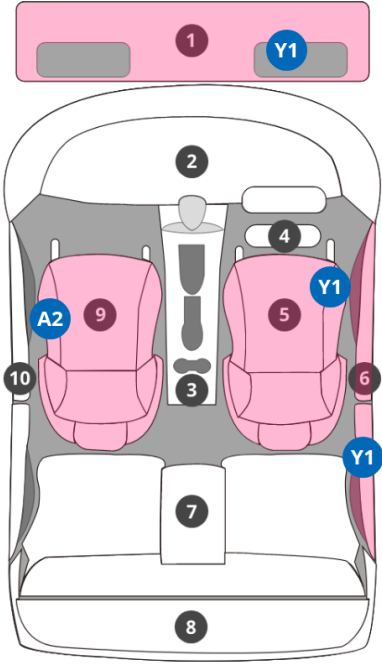
| Interior Evaluation : <b>A</b> | Exterior Evaluation : <b>D</b> |
|---|---|
| <p><b>Remarks</b><br/>Sunvisor, Sunglass Holder - Grime - Minimal / (R) Front Seat - Grime - Minimal / (R) Rear Trim - Grime - Minimal / (L) Front Seat - Cut, Crack - Small</p> | <p><b>Remarks</b><br/>(R) Front Fender, Molding - Scratch - Small / (R) Mirror - Scratch - Minimal / (R) Step, In-panel, Side Spoiler - Scratch - Minimal / Roof - Dent - Small / (R) Rear Door, Molding - Scratch - Small / (R) Side Gate - Scratch &amp; Dent - Small / Rear Bumper, Lamps, Panels - Scratch - Small / Rear Gate - Scratch &amp; Dent - Small / (L) Side Gate - Scratch &amp; Dent - Medium / (L) Rear Door, Molding - Scratch &amp; Dent - Minimal / (L) Front Door, Molding - Scratch &amp; Dent - Minimal / (L) Mirror - Scratch - Minimal / (L) Front Fender, Molding - Scratch &amp; Dent - Small / Front Bumper, Grille, Lamps - Scratch - Large / Bonnet, Headlight - Scratch - Minimal / (L) Step, In-panel, Side Spoiler - Scratch - Minimal / (R) Front Door, Molding - Scratch &amp; Dent - Minimal / Cab Back Panel - Scratch - Large</p> |

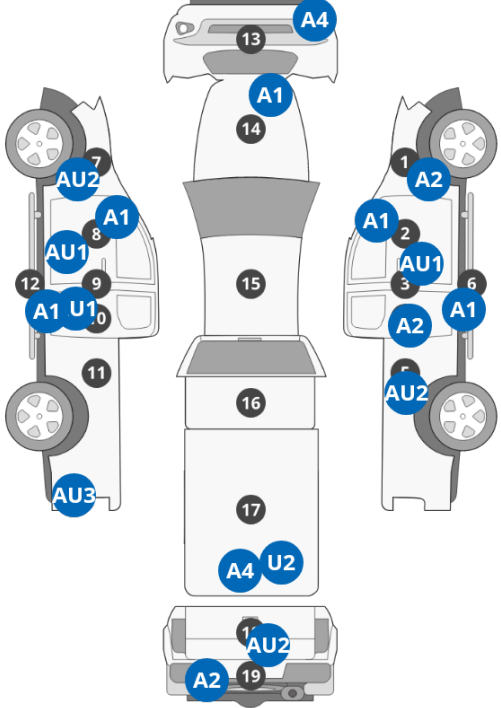
| Inspector Notes |
|---|
| With Lto plate, with spare tire and warranty booklet, 1key, no jack and tools, scratches on headlights and taillights, plate light issue |
