## General Information

| Make | Toyota | Model | Vios |

## Body / Panel Condition

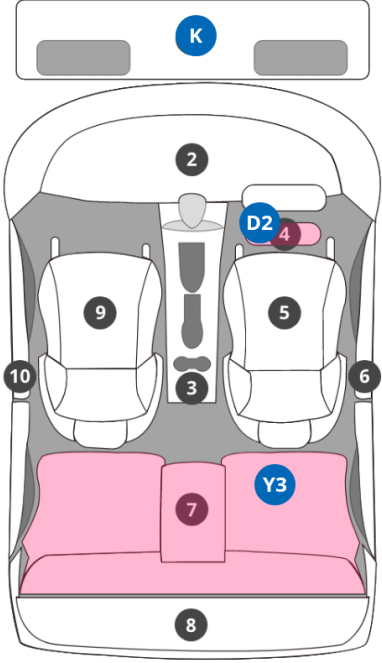
| <b>Remarks</b><br>Overall Interior - Animal Hair - Yes / Rear Seat - Grime - Medium / (L) Front Floor Mat - Worked - Small | <b>Remarks</b><br>Bonnet, Headlight - Scratch & Dent - Small / Rear Bumper, Lamps, Panels - Scratch & Dent - Large / (R) Rear Door, Molding - Scratch - Small / (R) Front Door, Molding - Scratch - Medium / (L) Rear Fender, Molding - Dent - Small / (L) Step, In-panel, Side Spoiler - Scratch - Small / Front Bumper, Grille, Lamps - Scratch - Medium |
