## General Information

| Make | Toyota | Model | Vios |

## Body / Panel Condition

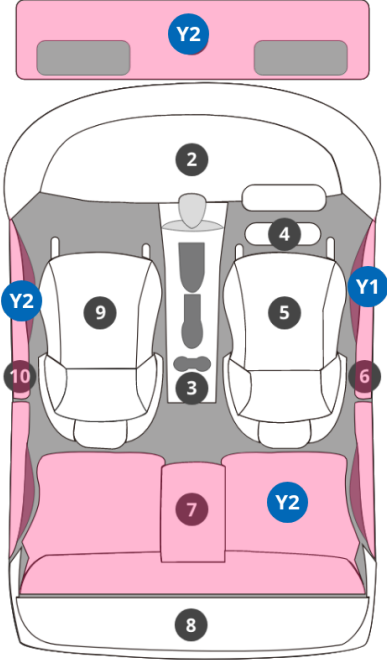
| Interior Evaluation : <b>A</b> | Exterior Evaluation : <b>E</b> |
| <p><b>Remarks</b><br/>Ceiling - Grime - Small / Rear Seat - Grime - Small / (R) Front Trim - Grime - Minimal / (L) Front Trim - Grime - Small</p> | <p><b>Remarks</b><br/>(L) Front Fender - Repair Traces - Yes / (L) Front Door - Repair Traces - Yes / Member (Bolted) - Dent - Yes / (R) Front Fender, Molding - Scratch &amp; Dent - Large / (R) Front Door, Molding - Scratch &amp; Dent - Large / (R) Step, In-panel, Side Spoiler - Scratch - Minimal / (R) Mirror - Scratch - Minimal / (R) Rear Door, Molding - Scratch &amp; Dent - Large / (R) Rear Fender, Molding - Scratch - Large / Rear Bumper, Lamps, Panels - Scratch - Large / Trunk Hood, Rear Gate - Scratch - Minimal / (L) Rear Fender, Molding - Scratch - Small / (L) Rear Door, Molding - Scratch - Minimal / (L) Front Door, Molding - Scratch &amp; Dent - Small / (L) Step, In-panel, Side Spoiler - Scratch - Minimal / (L) Mirror - Scratch - Minimal / (L) Front Fender, Molding - Scratch - Small / Roof - Scratch - Large / Front Bumper, Grille, Lamps - Scratch &amp; Dent - Large / Bonnet, Headlight - Scratch &amp; Dent - Minimal</p> |
