## General Information

| Make | Toyota | Model | Vios |
| YOM | 2025 | Odo Meter Reading | 30,586 |

## Body / Panel Condition

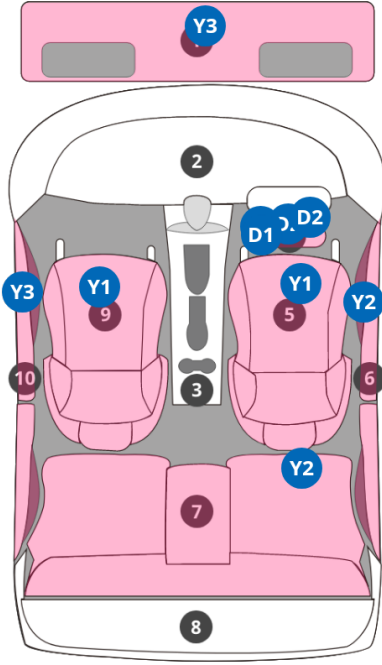
| Interior Evaluation : <span style="color: red;">C</span> | Exterior Evaluation : <span style="color: red;">D</span> |
|---|---|
| <p><b>Remarks</b><br/>Ceiling - Grime - Medium / (R) Front Floor Mat - Worked - Small / (R) Front Trim - Grime - Small / (R) Front Seat - Grime - Minimal / Rear Seat - Grime - Small / Mat Other - Worked - Small / (L) Front Trim - Grime - Medium / (L) Front Seat - Grime - Minimal / (L) Front Floor Mat - Worked - Small / Carpet - Worked - Minimal</p> | <p><b>Remarks</b><br/>(R) Front Fender, Molding - Scratch - Small / (R) Front Door, Molding - Scratch &amp; Dent - Small / (R) Rear Door, Molding - Scratch &amp; Dent - Small / (R) Step, In-panel, Side Spoiler - Scratch - Small / (R) Rear Fender, Molding - Scratch - Small / Rear Bumper, Lamps, Panels - Scratch - Large / Trunk Hood, Rear Gate - Scratch - Minimal / (L) Rear Fender, Molding - Scratch - Minimal / (L) Rear Door, Molding - Scratch - Minimal / (L) Front Door, Molding - Scratch - Small / (L) Step, In-panel, Side Spoiler - Scratch - Minimal / (L) Front Fender, Molding - Scratch &amp; Dent - Medium / Front Bumper, Grille, Lamps - Scratch &amp; Dent - Large / Bonnet, Headlight - Scratch - Small</p> |

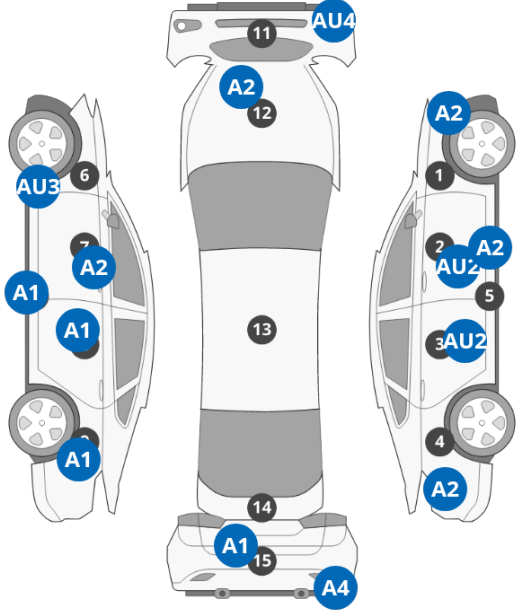
| Inspector Notes |
|---|
| With Lto plate, with warranty booklet and tools and Jack, 2keys, no spare tire, scratches on headlights and taillights,Worn front tires |
