## General Information

| Make | Toyota | Model | Avanza |

## Body / Panel Condition

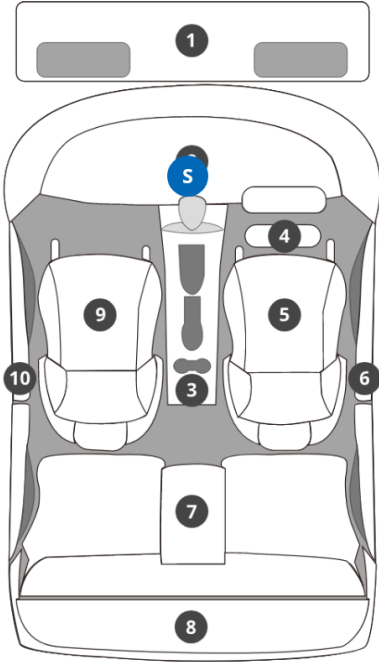
| Interior Evaluation : <b>B</b> | Exterior Evaluation : <b>E</b> |
| <b>Remarks</b><br>Overall Interior - Smell - Yes | <b>Remarks</b><br>Front Bumper, Grille, Lamps - Scratch & Dent - Large / (R) Front Fender, Molding - Scratch & Dent - Large / (R) Step, In-panel, Side Spoiler - Scratch & Dent - Large / (R) Rear Door, Molding - Scratch & Dent - Small / (R) Rear Fender, Molding - Scratch - Large / Rear Bumper, Lamps, Panels - Scratch & Dent - Large / Trunk Hood, Rear Gate - Scratch & Dent - Large / (L) Rear Door, Molding - Scratch & Dent - Small / (L) Front Door, Molding - Scratch - Small / (L) Front Fender, Molding - Scratch - Small / Bonnet, Headlight - Scratch - Small |
