## General Information

| Make | Toyota | Model | Vios |
| YOM | 2023 | Odo Meter Reading | 119,524 |
| Registration No. | NHI6572 | Chassis No. | PA1B18F37P4207420 |

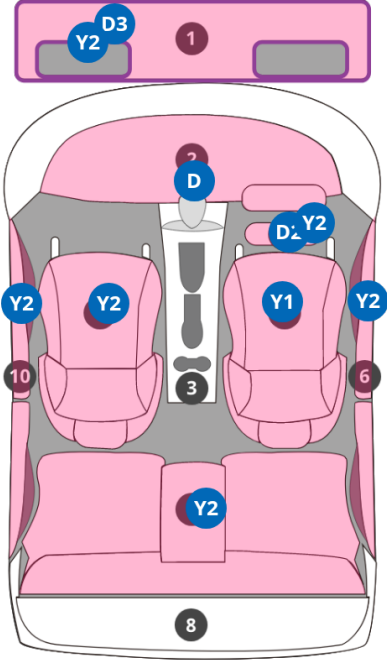
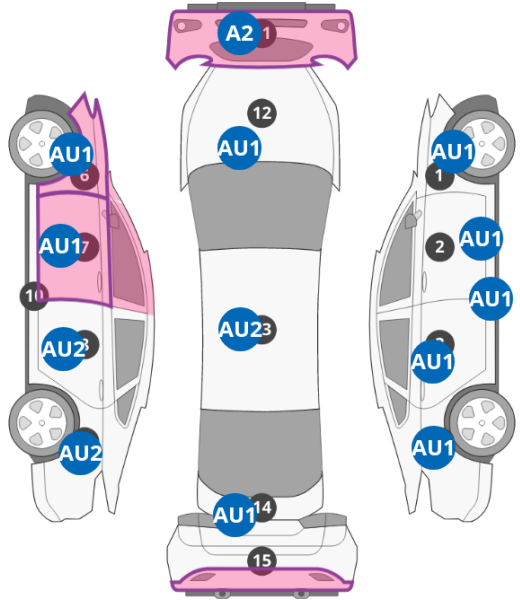
| Interior Evaluation : <span style="color: red;">C</span> | Exterior Evaluation : <span style="color: red;">C</span> |
|---|---|
| <p><b>a</b> : Cut, Fray <b>d</b> : Loose, Deformed <b>k</b> : Animal Hair <b>s</b> : Smell <b>t</b> : Cigarette Burns <b>x</b> : Defective <b>y</b> : Stain</p> | <p><b>A</b> : Scratch <b>AU</b> : Scratch &amp; Dent <b>B</b> : Modified <b>C</b> : Corrosion <b>G</b> : Stone chip <b>P</b> : Faded <b>S</b> : Rust <b>SC</b> : Rust &amp; Corrosion <b>U</b> : Dent <b>X</b> : Defective <b>Y</b> : Crack, Gap</p> |
| <p><b>Remarks</b></p> <p>(L) Front Floor Mat - Worked - Small / (R) Front Floor Mat - Grime - Small / (R) Front Seat - Grime - Minimal / (L) Front Seat - Grime - Small / Rear Seat - Grime - Small / (L) Front Trim - Grime - Small / (R) Front Trim - Grime - Small / Ceiling - Crinkle - Medium / Sunvisor, Sunglass Holder - Grime - Small / Dashboard - Traces of Adhesive Tape - Yes / Room Lamp - Missing - Yes</p> | <p><b>Remarks</b></p> <p>(R) Front Door - Repair Traces - Yes / (R) Front Fender - Repair Traces - Yes / Bonnet - Repair Traces - Yes / (L) Front Fender - Repair Traces - Yes / Trunk Hood, Rear Gate - Repair Traces - Yes / Trunk Hood, Rear Gate - Scratch &amp; Dent - Minimal / Rear Bumper, Lamps, Panels - Repair mark - Yes / (L) Rear Fender, Molding - Scratch &amp; Dent - Small / (L) Rear Door, Molding - Scratch &amp; Dent - Small / Roof - Scratch &amp; Dent - Small / (L) Front Fender, Molding - Repair mark - Yes / (L) Front Door, Molding - Repair mark - Yes / (L) Front Door, Molding - Scratch &amp; Dent - Minimal / (L) Front Fender, Molding - Scratch &amp; Dent - Minimal / Front Bumper, Grille, Lamps - Repair mark - Yes / Bonnet, Headlight - Scratch &amp; Dent - Minimal / (R) Front Fender, Molding - Scratch &amp; Dent - Minimal / (R) Front Door, Molding - Scratch &amp; Dent - Minimal / (R) Rear Door, Molding - Scratch &amp; Dent - Minimal / (R) Step, In-panel, Side Spoiler - Scratch &amp; Dent - Minimal / (R) Rear Fender, Molding - Scratch &amp; Dent - Minimal / Front Bumper, Grille, Lamps - Scratch - Small</p> |
