## General Information

| Make | Toyota | Model | Vios |
| Registration No. | NIJ3650 | Chassis No. | PA1B18F31P4204013 |

## Body / Panel Condition

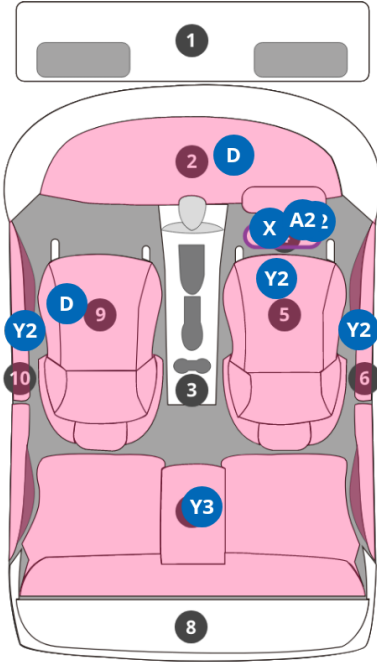
| Interior Evaluation : <span style="color: red;">C</span> | Exterior Evaluation : <span style="color: red;">E</span> |
|---|---|
| <p><b>Remarks</b></p> <p>Dashboard - Traces of Adhesive Tape - Yes / Rear Seat - Grime - Medium / (R) Front Trim - Grime - Small / (R) Front Floor Mat - Worked - Small / (L) Front Floor Mat - Missing - Yes / (R) Front Seat - Grime - Small / (L) Front Trim - Grime - Small / (L) Front Seat - Worn - Yes / Carpet - Worn, Scratch, Cut, Crack - Small</p> | <p><b>Remarks</b></p> <p>(R) Front Door - Repair Traces - Yes / (R) Front Fender - Repair Traces - Yes / Bonnet - Repair Traces - Yes / (L) Front Fender - Repair Traces - Yes / (L) Front Door - Repair Traces - Yes / (L) Rear Door - Repair Traces - Yes / (L) Rear Fender - Repair Traces - Yes / Trunk Hood, Rear Gate - Repair Traces - Yes / (R) Rear Fender - Repair Traces - Yes / (R) Rear Door - Repair Traces - Yes / Roof - Repair Traces - Yes / (R) Rear Fender, Molding - Repair mark - Yes / Trunk Hood, Rear Gate - Repair mark - Yes / (L) Rear Door, Molding - Repair mark - Yes / (L) Rear Fender, Molding - Repair mark - Yes / (L) Front Door, Molding - Repair mark - Yes / (L) Front Fender, Molding - Scratch - Small / (L) Mirror - Scratch - Minimal / (L) Step, In-panel, Side Spoiler - Scratch &amp; Dent - Small / (L) Front Door, Molding - Scratch - Small / (L) Rear Door, Molding - Scratch - Small / (L) Rear Fender, Molding - Scratch &amp; Dent - Small / Trunk Hood, Rear Gate - Scratch &amp; Dent - Small / Rear Bumper, Lamps, Panels - Scratch &amp; Dent - Medium / (R) Rear Fender, Molding - Scratch - Small / (R) Rear Door, Molding - Scratch - Small / (R) Step, In-panel, Side Spoiler - Scratch &amp; Dent - Small / (R) Front Door, Molding - Scratch &amp; Dent - Small / (R) Mirror - Scratch - Minimal / (R) Front Fender, Molding - Scratch - Minimal / Front Bumper, Grille, Lamps - Scratch - Medium / Bonnet, Headlight - Scratch - Minimal / Roof - Scratch - Minimal</p> |

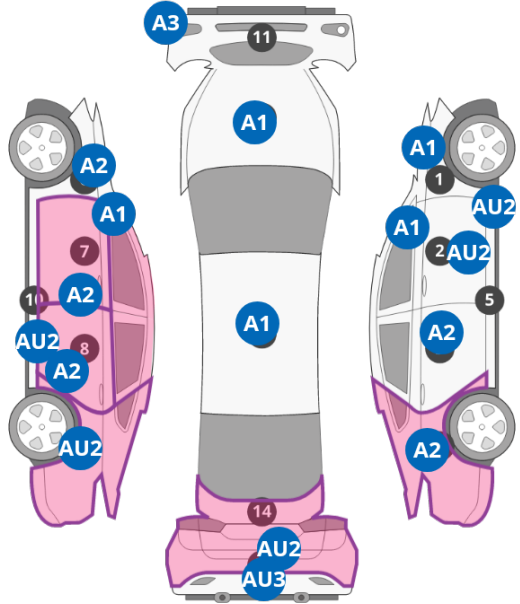
| Inspector Notes |
|---|
| <p>with LTO plate/no warranty booklet/with incomplete tools with jack/with spare tire/no spare key/traces of adhesive on front windshield and rear view mirror/plate light issue/abnormal vibration/scratches on taillight cover/hairline scratches on the body</p> |
