## General Information

| Make | Toyota | Model | Rush |
| Registration No. | FAR2493 | Chassis No. | MHKE8FF3PRK060029 |

## Body / Panel Condition

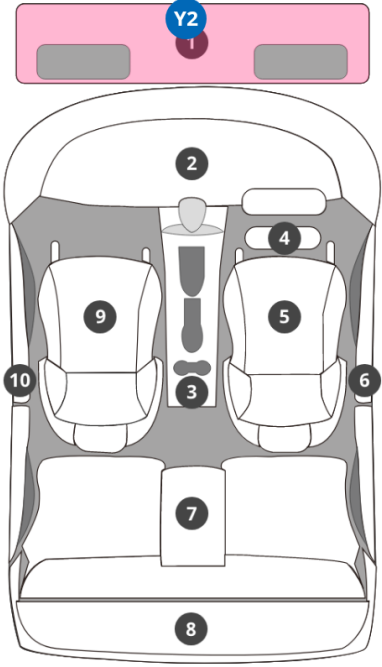
| Interior Evaluation : <b>A</b> | Exterior Evaluation : <b>C</b> |
| <b>Remarks</b><br>Ceiling - Grime - Small | <b>Remarks</b><br>(R) Front Fender, Molding - Scratch - Small / Supplemental Mirror - Scratch, Peeled - Minimal / (R) Front Door, Molding - Dent - Small / (R) Rear Fender, Molding - Scratch - Small / Rear Bumper, Lamps, Panels - Scratch & Dent - Large / (L) Rear Fender, Molding - Scratch & Dent - Large / Front Bumper, Grille, Lamps - Scratch & Dent - Large |

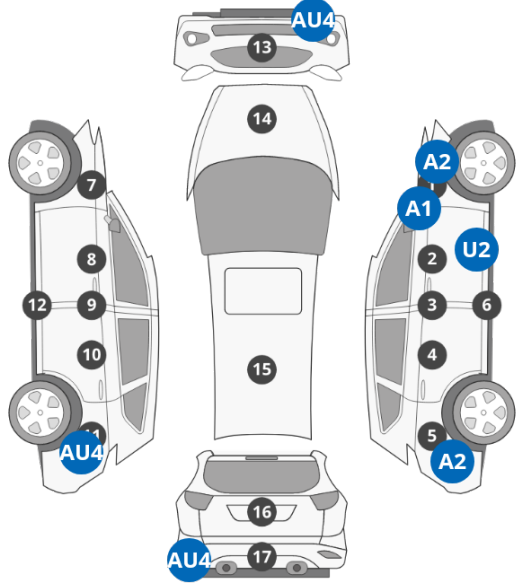
with Ito plate, with warranty booklet, stereo not working, reverse cam not working, left tail light concern, hairline scratches in the body, with jack, with tools, with spare tire
