## General Information

| Make | Toyota | Model | Wigo |
| YOM | 2024 | Odo Meter Reading | 14,506 |
| Registration No. | FAR9942 | Chassis No. | MHKAA1BC6RJ022161 |

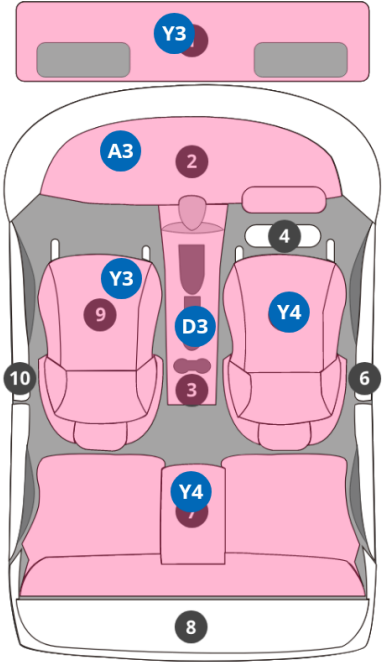
| Interior Evaluation : <span style="color: red;">C</span> | Exterior Evaluation : <span style="color: red;">E</span> |
|---|---|
| <b>Remarks</b><br>Instrument Panel - Worn, Scratch, Cut, Crack - Medium / Console, Switches, Vents - Loose, Deformed - Medium / (R) Front Seat - Grime - Large / (L) Front Seat - Grime - Medium / Ceiling - Grime - Medium / Rear Seat - Grime - Large | <b>Remarks</b><br>Front Bumper, Grille, Lamps - Scratch & Dent - Large / (R) Front Fender, Molding - Scratch - Small / (R) Mirror - Scratch, Peeled - Yes / (R) Front Door, Molding - Scratch - Small / (R) Rear Door, Molding - Scratch - Large / (R) Rear Fender, Molding - Scratch - Small / Rear Bumper, Lamps, Panels - Scratch - Medium / Trunk Hood, Rear Gate - Scratch - Small / (L) Rear Door, Molding - Scratch & Dent - Large / (L) Rear Fender, Molding - Scratch - Medium / (L) Front Door, Molding - Scratch - Medium / (L) Front Fender, Molding - Scratch - Medium / Bonnet, Headlight - Scratch & Dent - Small / (L) Mirror - Scratch, Peeled - Yes |

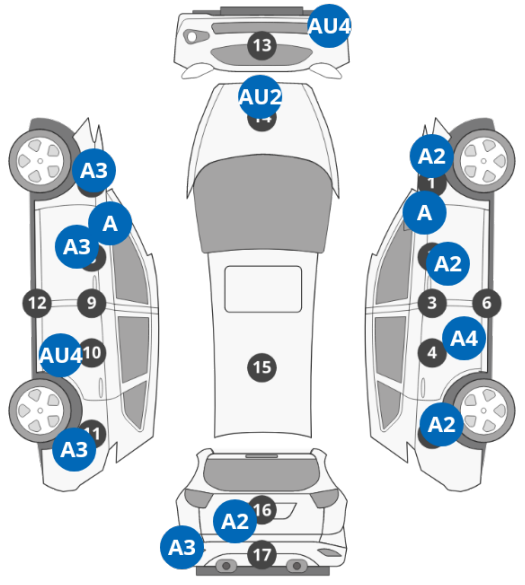
with Ito plate, with warranty booklet, with jack, with spare tire, with tools, scratch on left head light, radio / display issue, hairline scratches in the body
