## General Information

| Make | Toyota | Model | Vios |
| YOM | 2024 | Mileage | 6,812 |
| Registration No. | NIU8688 | Chassis No. | PA1B18F37R4240310 |

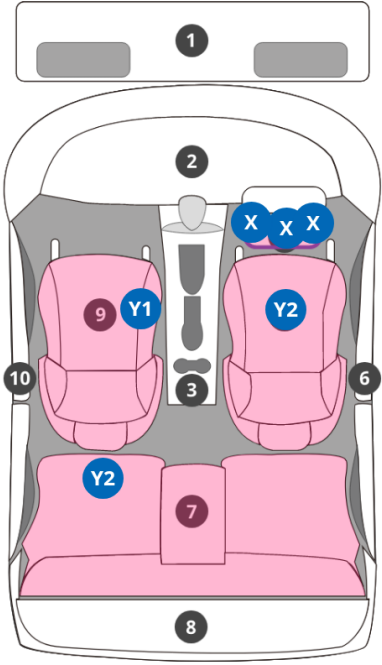
| Interior Evaluation : <b>B</b> | Exterior Evaluation : <b>C</b> |
| <p><b>Remarks</b></p> <p>Mat Other - Missing - Yes / (R) Front Floor Mat - Missing - Yes / (L) Front Floor Mat - Missing - Yes / (R) Front Seat - Grime - Small / Rear Seat - Grime - Small / (L) Front Seat - Grime - Minimal</p> | <p><b>Remarks</b></p> <p>(R) Rear Fender, Molding - Dent - Minimal / (L) Rear Door, Molding - Scratch - Large / Front Bumper, Grille, Lamps - Scratch - Large</p> |

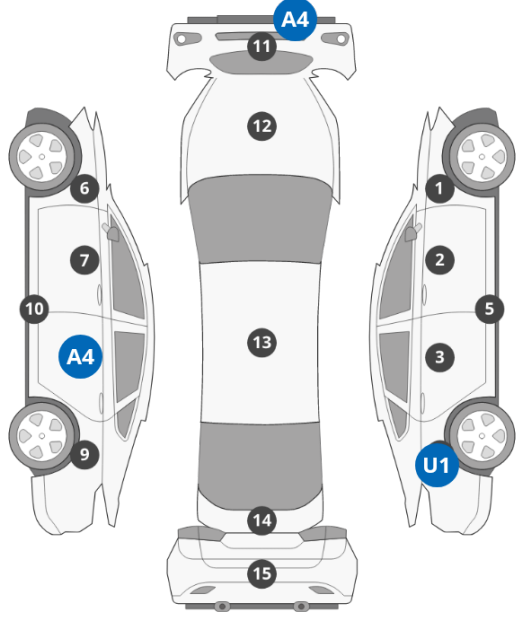
with warranty booklet and jack. without spare tire and tools. with LTO plate. small gap at the right front bumper.
