## General Information

| Make | Toyota | Model | Vios |
| YOM | 2026 | Odo Meter Reading | 22,709 |
| Registration No. | NKU8772 | Chassis No. | PA1B18F3X4298689 |

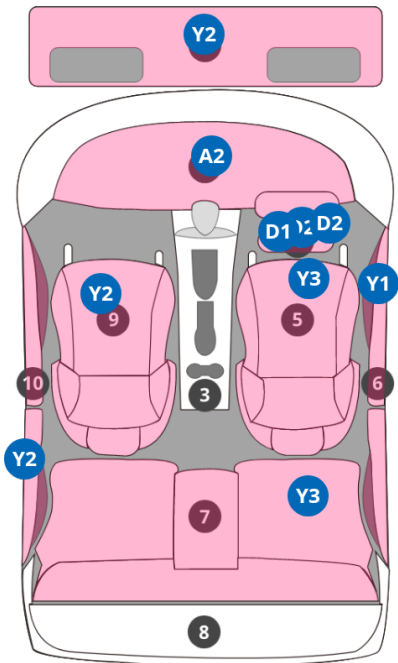
| Interior Evaluation : <span style="color: red;">C</span> | Exterior Evaluation : <span style="color: red;">D</span> |
| <b>Remarks</b><br>Ceiling - Grime - Small / Rear Seat - Grime - Medium / Mat Other - Worked - Small / Carpet - Worked - Minimal / (R) Front Trim - Grime - Minimal / (R) Front Seat - Grime - Medium / (L) Rear Trim - Grime - Small / (L) Front Seat - Grime - Small / (L) Front Floor Mat - Worked - Small / Dashboard - Worn, Scratch, Cut, Crack - Small | <b>Remarks</b><br>(R) Front Door - Repair Traces - Yes / (R) Front Fender - Repair Traces - Yes / (L) Front Fender - Repair Traces - Yes / (L) Front Door - Repair Traces - Yes / (L) Step - Repair Traces - Yes / (L) Rear Door - Repair Traces - Yes / (L) Rear Fender - Repair Traces - Yes / Roof - Repair Traces - Yes / (R) Front Fender, Molding - Scratch & Dent - Small / (R) Mirror - Scratch - Minimal / (R) Front Door, Molding - Scratch & Dent - Minimal / (R) Rear Door, Molding - Scratch - Minimal / (R) Rear Fender, Molding - Scratch & Dent - Minimal / (R) Step, In-panel, Side Spoiler - Scratch - Minimal / Rear Bumper, Lamps, Panels - Scratch - Large / Trunk Hood, Rear Gate - Scratch - Minimal / (L) Rear Fender, Molding - Repair mark - Yes / (L) Rear Door, Molding - Repair mark - Yes / (L) Rear Fender, Molding - Scratch - Minimal / (L) Rear Door, Molding - Scratch - Minimal / (L) Step, In-panel, Side Spoiler - Repair mark - Yes / (L) Step, In-panel, Side Spoiler - Scratch & Dent - Minimal / (L) Mirror - Scratch - Minimal / Roof - Dent - Small / (L) Front Door, Molding - Scratch & Dent - Small / (L) Front Fender, Molding - Scratch & Dent - Medium / Front Bumper, Grille, Lamps - Scratch & Dent - Medium / Bonnet, Headlight - Scratch & Dent - Small |

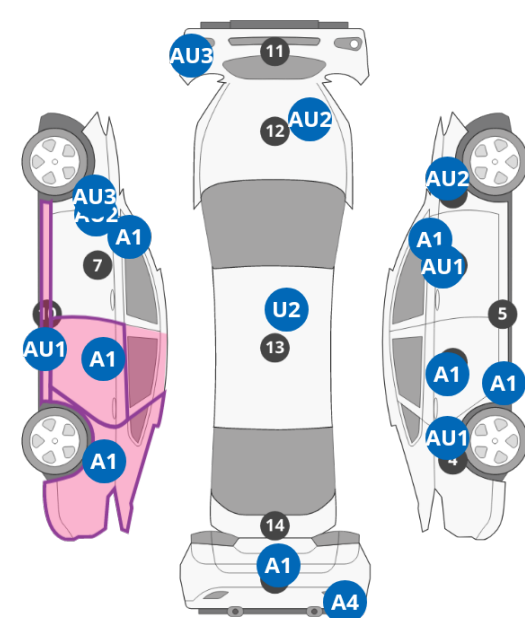
| Inspector Notes |
|---|
| With Lto plate, with spare tire and jack and tools, 3keys, no warranty booklet, scratches on headlights and taillights, battery weak |
