## General Information

| Make | Toyota | Model | Vios |
| YOM | 2024 | Mileage | 8,432 |
| Registration No. | DBP1653 | Chassis No. | PA1B18F3XR4260227 |

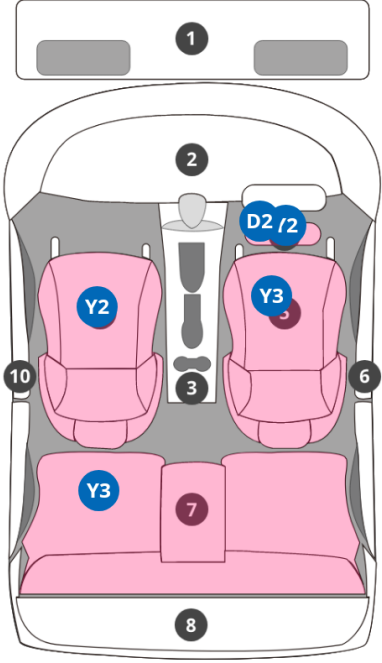
| <b>Interior Evaluation :</b> <span style="color: red; font-weight: bold;">B</span> | <b>Exterior Evaluation :</b> <span style="color: red; font-weight: bold;">C</span> |
| <b>Remarks</b><br>(R) Front Seat - Grime - Medium / Rear Seat - Grime - Medium / Mat Other - Grime - Small / (L) Front Seat - Grime - Small / (L) Front Floor Mat - Worked - Small | <b>Remarks</b><br>Rear Bumper, Lamps, Panels - Scratch - Minimal / (R) Front Fender, Molding - Scratch & Dent - Large / (R) Front Door, Molding - Scratch & Dent - Medium / (R) Rear Door, Molding - Scratch - Medium / (R) Rear Fender, Molding - Scratch - Small / Front Bumper, Grille, Lamps - Scratch - Small |
