## General Information

| Make | Toyota | Model | Vios |
| YOM | 2024 | Mileage | 9,098 |
| Registration No. | NHH6776 | Chassis No. | PA1B18F33R4248937 |

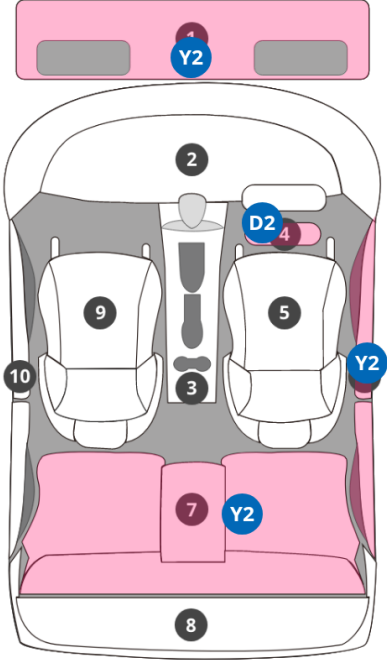
| <b>Interior Evaluation :</b> <span style="color: red; font-weight: bold;">A</span> | <b>Exterior Evaluation :</b> <span style="color: red; font-weight: bold;">B</span> |
| <b>Remarks</b><br>Ceiling - Grime - Small / (R) Front Trim - Grime - Small / Rear Seat - Grime - Small / (L) Front Floor Mat - Worked - Small | <b>Remarks</b><br>Front Bumper, Grille, Lamps - Scratch - Medium / (R) Front Door, Molding - Scratch - Minimal / (L) Rear Door, Molding - Scratch - Medium |
