## General Information

| Make | Toyota | Model | Raize |
| YOM | 2023 | Odo Meter Reading | 24,828 |
| Registration No. | NFA5426 | Chassis No. | MHKAA1BA9PJ087422 |

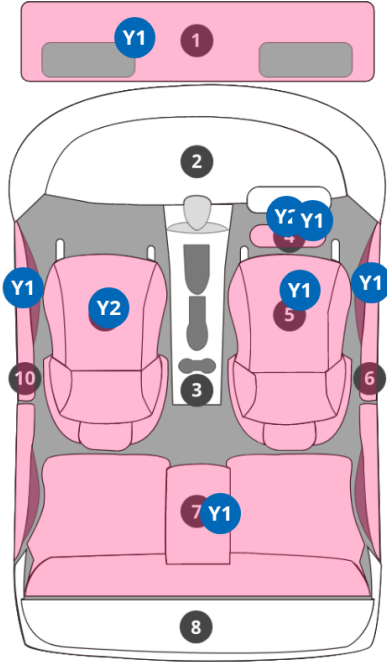
| Interior Evaluation : <b>A</b> | Exterior Evaluation : <b>C</b> |
| <p><b>Remarks</b><br/>(L) Front Floor Mat - Grime - Small / (R) Front Floor Mat - Grime - Minimal / (L) Front Seat - Grime - Small / (R) Front Seat - Grime - Minimal / (L) Front Trim - Grime - Minimal / (R) Front Trim - Grime - Minimal / Rear Seat - Grime - Minimal / Ceiling - Grime - Minimal</p> | <p><b>Remarks</b><br/>(R) Front Fender - Repair Traces - Yes / (L) Front Fender - Repair Traces - Yes / Rear Bumper, Lamps, Panels - Scratch - Medium / Trunk Hood, Rear Gate - Scratch &amp; Dent - Minimal / (R) Rear Fender, Molding - Scratch - Small / (R) Rear Door, Molding - Scratch &amp; Dent - Minimal / (R) Front Door, Molding - Scratch &amp; Dent - Small / (R) Front Fender, Molding - Scratch &amp; Dent - Minimal / Bonnet, Headlight - Dent - Medium / (L) Front Fender, Molding - Scratch &amp; Dent - Minimal / (L) Front Door, Molding - Scratch &amp; Dent - Minimal / (L) Rear Door, Molding - Scratch &amp; Dent - Small / Roof - Scratch &amp; Dent - Minimal / (L) Step, In-panel, Side Spoiler - Scratch - Minimal / (R) Step, In-panel, Side Spoiler - Scratch - Minimal / (L) Rear Fender, Molding - Scratch &amp; Dent - Minimal / Front Bumper, Grille, Lamps - Scratch - Small / Front Windshield - Scratch, Stone chip - Small</p> |

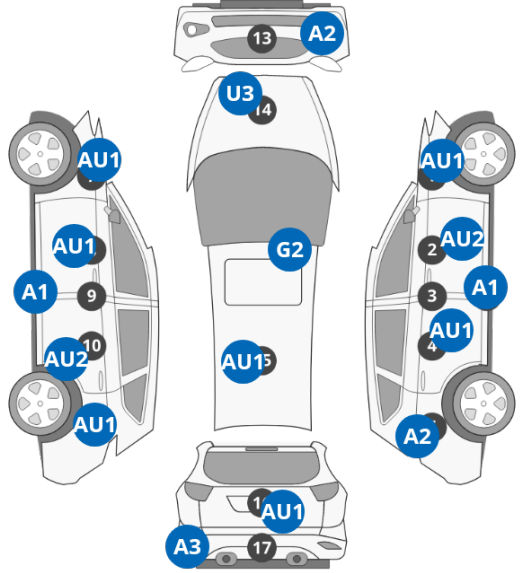
with LTO plate, with spare tire, with reverse camera, with manual and warranty booklet, with jack, no spare key, no tools, scratches and dent on exterior, scratches on taillight and headlight, check engine indicator, engine control system and VSC system indicator on, windshield issue.
