## General Information

| Make | Toyota | Model | Hilux |
| Registration No. | PUQ447 | Chassis No. | MR0ER32GX06009223 |

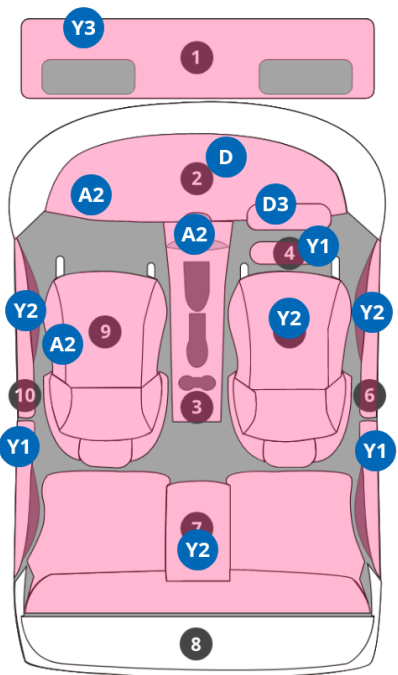
| Interior Evaluation : <b>C</b> | Exterior Evaluation : <b>E</b> |
| <p><b>Remarks</b></p> <p>(R) Front Seat - Grime - Small / Rear Seat - Grime - Small / (R) Rear Trim - Grime - Minimal / (R) Front Trim - Grime - Small / (R) Front Floor Mat - Grime - Minimal / (L) Rear Trim - Grime - Minimal / (L) Front Trim - Grime - Small / Dashboard - Traces of Adhesive Tape - Yes / Dashboard - Loose, Deformed - Medium / Steering Wheel - Worn, Peel, Crack - Small / Overall Interior - Worn as per age - Yes / Ceiling - Grime - Medium / Console, Switchs, Vents - Worn, Scratch, Cut, Crack - Small / (L) Front Seat - Cut, Crack - Small</p> | <p><b>Remarks</b></p> <p>(R) Front Fender, Molding - Scratch &amp; Dent - Small / Front Bumper, Grille, Lamps - Scratch &amp; Dent - Large / (R) Front Door, Molding - Scratch - Small / (R) Step, In-panel, Side Spoiler - Scratch - Medium / (R) Rear Door, Molding - Scratch - Medium / (R) Side Gate - Scratch &amp; Dent - Large / Rear Gate - Scratch &amp; Dent - Medium / Rear Bumper, Lamps, Panels - Scratch &amp; Dent - Large / (L) Side Gate - Scratch &amp; Dent - Medium / (L) Rear Door, Molding - Scratch &amp; Dent - Large / (L) Rear Corner Panel - Scratch &amp; Dent - Small / (L) Step, In-panel, Side Spoiler - Scratch - Medium / (L) Front Door, Molding - Scratch - Medium / (L) Front Fender, Molding - Scratch &amp; Dent - Small / Bonnet, Headlight - Scratch &amp; Dent - Small / Roof - Scratch - Small / Overall Exterior - Worn as per age - Yes</p> |
