## General Information

| Make | Toyota | Model | Hiace |
| YOM | 2019 | Odo Meter Reading | 341,023 |
| Registration No. | DAL6553 | Chassis No. | JTFJT02P0K5020977 |

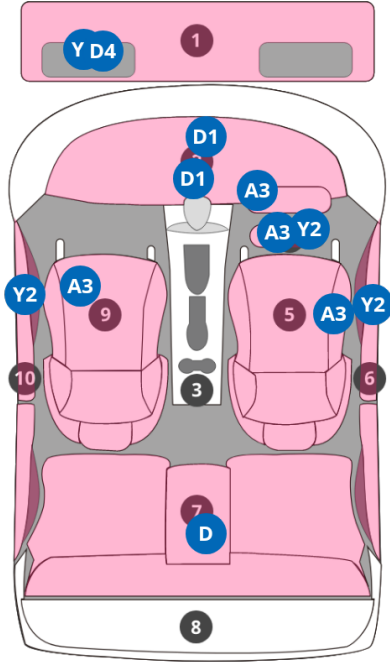
| Interior Evaluation : <b>D</b> | Exterior Evaluation : <b>E</b> |
| <p><b>Remarks</b></p> <p>(L) Front Floor Mat - Cut, Crack - Medium / (R) Front Floor Mat - Grime - Small / (L) Front Seat - Cut, Crack - Medium / (R) Front Seat - Fray - Medium / Rear Seat - Worn - Yes / (R) Front Trim - Grime - Small / (L) Front Trim - Grime - Small / Dashboard - Worked - Minimal / Ceiling - Grime - Small / Sunvisor, Sunglass Holder - Worked - Large / Steering Wheel - Worn, Peel, Crack - Medium / Instrument Panel - Worked - Minimal</p> | <p><b>Remarks</b></p> <p>(R) Front Door - Repair Traces - Yes / Front Panel - Repair Traces - Yes / Front Panel - Replaced - Yes / (L) Front Door - Repair Traces - Yes / (L) Rear Fender - Repair Traces - Yes / Trunk Hood, Rear Gate - Repair Traces - Yes / (R) Rear Fender - Repair Traces - Yes / (R) Rear Door - Repair Traces - Yes / (R) Center Panel - Repair Traces - Yes / Roof - Repair Traces - Yes / Trunk Hood, Rear Gate - Repair mark - Yes / (R) Rear Fender, Molding - Repair mark - Yes / (R) Rear Fender, Molding - Scratch &amp; Dent - Small / Trunk Hood, Rear Gate - Scratch &amp; Dent - Small / Rear Bumper, Lamps, Panels - Scratch - Small / (R) Rear Door, Molding - Scratch &amp; Dent - Medium / Overall Exterior - Faded(Color, Gloss) - Yes / (R) Center Panel - Scratch - Small / (R) Front Door, Molding - Repair mark - Yes / (R) Front Door, Molding - Scratch &amp; Dent - Small / Front Bumper, Grille, Lamps - Scratch &amp; Dent - Small / Front Panel - Rust, Corrosion - Minimal / (L) Front Door, Molding - Scratch &amp; Dent - Small / (L) Step, In-panel, Side Spoiler - Repair mark - Yes / (L) Front Door, Molding - Repair mark - Yes / (L) Step, In-panel, Side Spoiler - Scratch &amp; Dent - Small / (L) Rear Fender, Molding - Scratch - Medium / Roof - Scratch &amp; Dent - Small / Roof - Repair mark - Yes / (L) Front Fender, Molding - Scratch - Minimal / (R) Front Fender, Molding - Scratch - Minimal / (R) Step, In-panel, Side Spoiler - Scratch &amp; Dent - Minimal</p> |

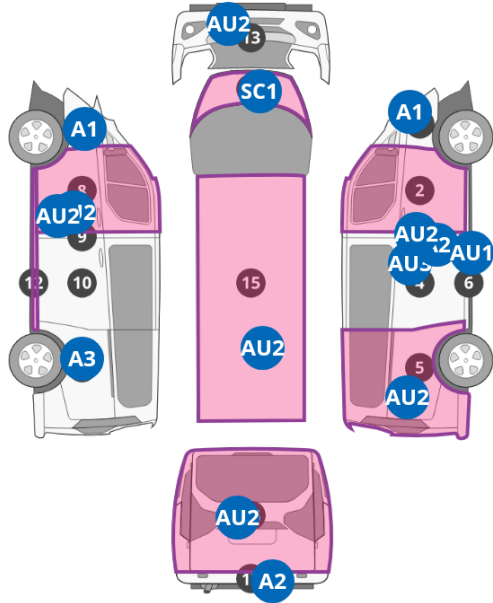
| Inspector Notes |
|---|
| <p>with LTO plate, with spare tire and key, with warranty and manual booklet, no tools and jack, issue on rear slide door, issue in sun visor, issue in glass slide rear door area, scratches and dent on exterior, scratches in taillight and headlight, issue on underchassis.</p> |
