## General Information

| Make | Mitsubishi | Model | Mirage |
| YOM | 2018 | Odo Meter Reading | 117,206 |
| Registration No. | NDP3364 | Chassis No. | PAEA13TJJJA006931 |

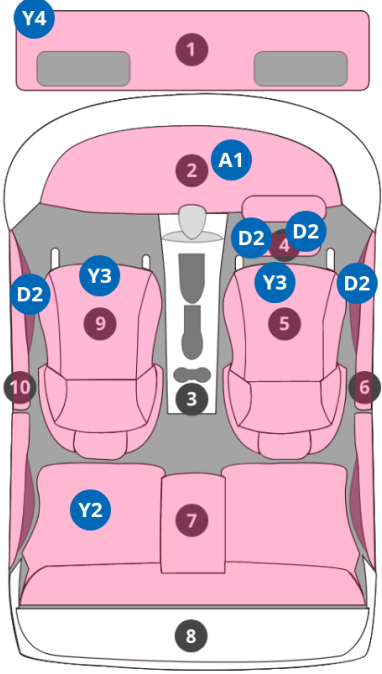
| Interior Evaluation : <span style="color: red; font-weight: bold;">C</span> | Exterior Evaluation : <span style="color: red; font-weight: bold;">C</span> |
| <p><b>Remarks</b></p> <p>(L) Front Seat - Grime - Medium / (R) Front Seat - Grime - Medium / Rear Seat - Grime - Small / Ceiling - Grime - Large / Overall Interior - Worn as per age - Yes / (L) Front Floor Mat - Worked - Small / (R) Front Floor Mat - Worked - Small / Glove Box - Worn, Scratch, Cut, Crack - Minimal / (L) Front Trim - Worked - Small / (R) Front Trim - Worked - Small</p> | <p><b>Remarks</b></p> <p>(R) Front Fender, Molding - Scratch - Minimal / (R) Front Door, Molding - Scratch - Minimal / (R) Rear Door, Molding - Dent - Minimal / (L) Rear Fender, Molding - Scratch - Minimal / (R) Rear Fender, Molding - Scratch - Minimal / Rear Bumper, Lamps, Panels - Scratch &amp; Dent - Minimal / Trunk Hood, Rear Gate - Scratch - Minimal / (L) Rear Door, Molding - Scratch &amp; Dent - Minimal / (L) Front Door, Molding - Scratch - Minimal / (L) Front Fender, Molding - Scratch - Minimal / Front Bumper, Grille, Lamps - Scratch - Minimal / Bonnet, Headlight - Scratch - Minimal / Overall Exterior - Worn as per age - Yes / Roof - Scratch - Minimal / (R) Step, In-panel, Side Spoiler - Scratch - Minimal / (L) Step, In-panel, Side Spoiler - Scratch - Minimal</p> |

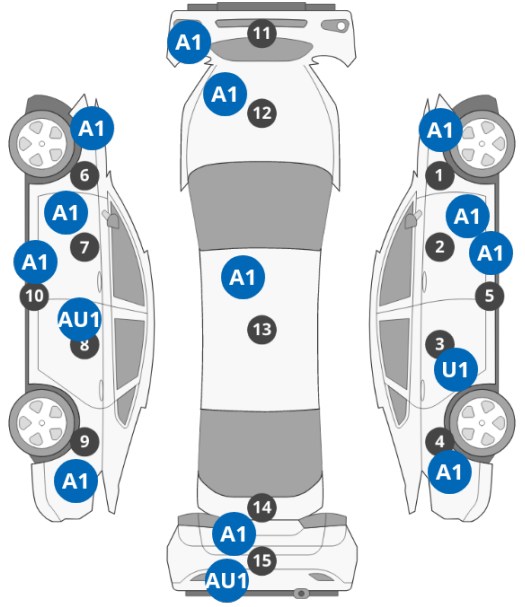
| Inspector Notes |
|---|
| <p>with Ito plate/warranty booklet/with hairlines scratches on the body/without tools and jack/without reverse camera/with driver seat issue/with plate light issue</p> |
