## General Information

| Make | Mitsubishi | Model | Mirage |
| Registration No. | NDP3354 | Chassis No. | PAEA13TJJJA006955 |

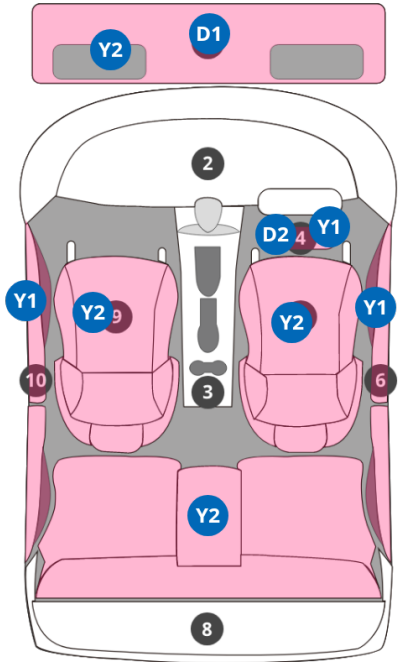
| Interior Evaluation : <b>B</b> | Exterior Evaluation : <b>C</b> |
|---|---|
| <b>Remarks</b><br>(L) Front Seat - Grime - Small / (R) Front Seat - Grime - Small / Rear Seat - Grime - Small / (L) Front Trim - Grime - Minimal / (R) Front Trim - Grime - Minimal / Ceiling - Crinkle - Minimal / Sunvisor, Sunglass Holder - Grime - Small / (L) Front Floor Mat - Worked - Small / (R) Front Floor Mat - Grime - Minimal | <b>Remarks</b><br>(R) Front Fender - Repair Traces - Yes / Bonnet - Repair Traces - Yes / (L) Front Fender - Repair Traces - Yes / (L) Front Door - Repair Traces - Yes / Roof - Scratch & Dent - Small / Bonnet, Headlight - Scratch & Dent - Minimal / (R) Front Fender, Molding - Scratch & Dent - Minimal / (R) Rear Door, Molding - Scratch & Dent - Minimal / (R) Front Door, Molding - Scratch & Dent - Minimal / (R) Step, In-panel, Side Spoiler - Scratch & Dent - Minimal / (R) Rear Fender, Molding - Scratch & Dent - Small / Rear Bumper, Lamps, Panels - Repair mark - Yes / Trunk Hood, Rear Gate - Scratch - Medium / (L) Rear Fender, Molding - Scratch & Dent - Minimal / (L) Rear Door, Molding - Scratch & Dent - Minimal / (L) Step, In-panel, Side Spoiler - Scratch & Dent - Small / (L) Front Door, Molding - Rust, Corrosion - Medium / (L) Front Fender, Molding - Scratch & Dent - Minimal / (L) Front Door, Molding - Repair mark - Yes / (L) Front Fender, Molding - Repair mark - Yes / Front Bumper, Grille, Lamps - Repair mark - Yes / Front Bumper, Grille, Lamps - Scratch - Small |

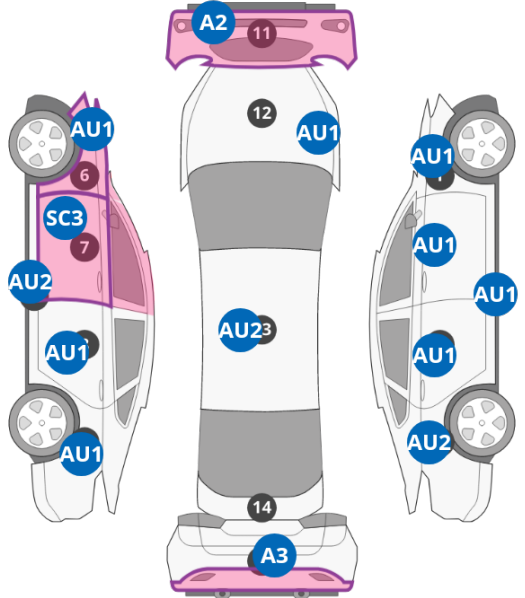
with LTO plate, with spare tire and key, with warranty and manual booklet, no jack and tools, no reverse camera, scratches and dent on exterior, scratches in taillight and headlight, brake rotor noise, underchassis issue.
