## General Information

| Make | Toyota | Model | Vios |
| Registration No. | NHN6309 | Chassis No. | PA1B18F36R4245756 |

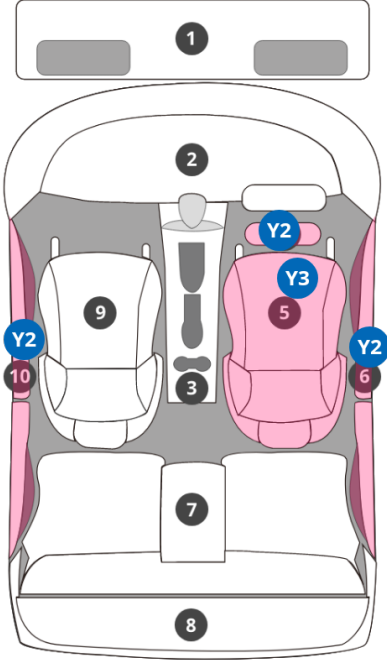
| <b>Remarks</b><br>(R) Front Seat - Grime - Medium / Mat Other - Grime - Small / (R) Front Trim - Grime - Small / (L) Front Trim - Grime - Small | <b>Remarks</b><br>(R) Mirror - Scratch - Minimal / (R) Front Door, Molding - Scratch & Dent - Large / Rear Bumper, Lamps, Panels - Scratch - Medium / Trunk Hood, Rear Gate - Scratch - Small / (L) Rear Door, Molding - Scratch - Medium / (L) Front Door, Molding - Scratch - Minimal / (L) Front Fender, Molding - Scratch - Minimal / Front Bumper, Grille, Lamps - Scratch - Medium / Bonnet, Headlight - Scratch - Medium / Roof - Scratch - Medium |
