## General Information

| Make | Toyota | Model | Hilux Tamaraw |
| Registration No. | CCQ6765 | Chassis No. | PAHACACA5S6429808 |

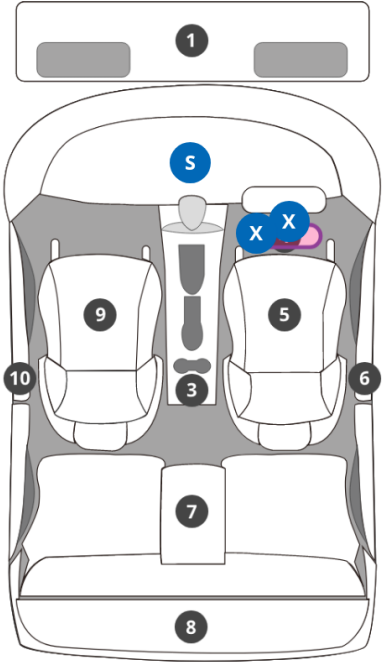
| Interior Evaluation : <b>B</b> | Exterior Evaluation : <b>E</b> |
|---|---|
| <b>Remarks</b><br>(L) Front Floor Mat - Missing - Yes / (R) Front Floor Mat - Missing - Yes / Overall Interior - Smell - Yes | <b>Remarks</b><br>(L) Side Gate - Scratch & Dent - Large / (L) Step, In-panel, Side Spoiler - Scratch & Dent - Small / Rear Bumper, Lamps, Panels - Scratch - Large / Cargo Bed Floor - Scratch & Dent - Large / (R) Guard Frame - Scratch - Large / (R) Side Gate - Scratch - Medium / (R) Front Door, Molding - Dent - Small / Front Bumper, Grille, Lamps - Scratch - Medium / (L) Guard Frame - Scratch - Medium |
