## General Information

| Make | Toyota | Model | Hilux Tamaraw |

## Body / Panel Condition

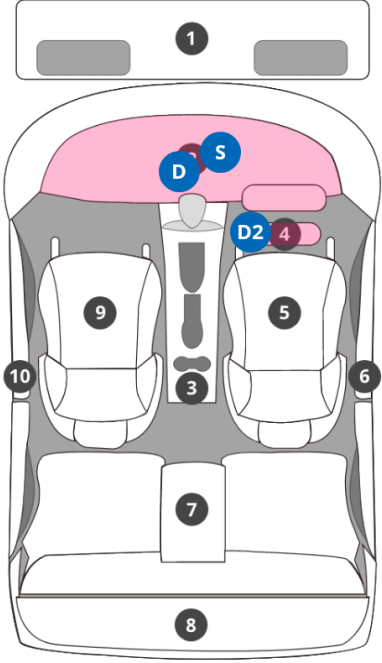
| Interior Evaluation : <b>B</b> | Exterior Evaluation : <b>E</b> |
| <p><b>Remarks</b><br/>Dashboard - Traces of Adhesive Tape - Yes / (L) Front Floor Mat - Worked - Small / Overall Interior - Smell - Yes</p> | <p><b>Remarks</b><br/>(L) Side Gate - Scratch &amp; Dent - Large / (L) Front Door, Molding - Scratch &amp; Dent - Large / Front Bumper, Grille, Lamps - Scratch &amp; Dent - Large / (R) Side Gate - Scratch - Large / (R) Guard Frame - Scratch &amp; Dent - Large / Rear Gate - Scratch - Medium / Cargo Bed Floor - Scratch &amp; Dent - Large / Roof - Scratch &amp; Dent - Large</p> |

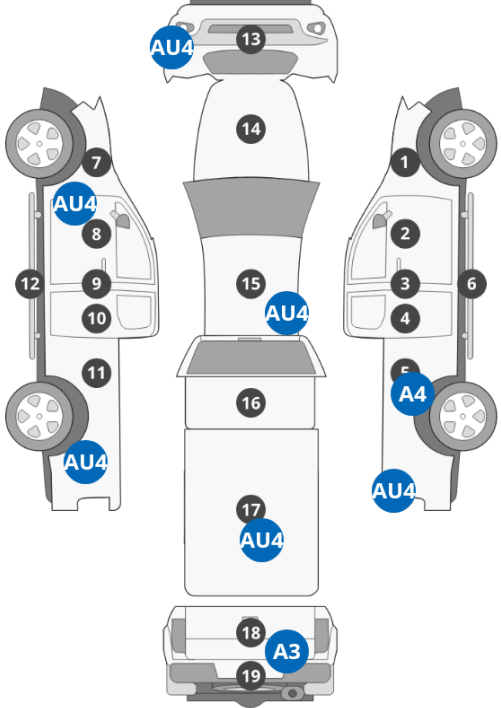
| Inspector Notes |
|---|
| <p>light scratches around the exterior/ possible flooding/ driver door issue/ with jack and spare tire/ with LTO plate and warranty booklet/ incomplete tools</p> |
