## General Information

| Make | Toyota | Model | Hilux Tamaraw |
| Registration No. | CDC1232 | Chassis No. | PAHACACA5S6433101 |

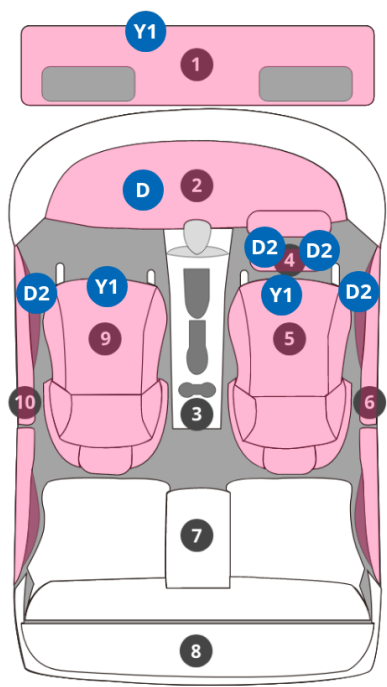
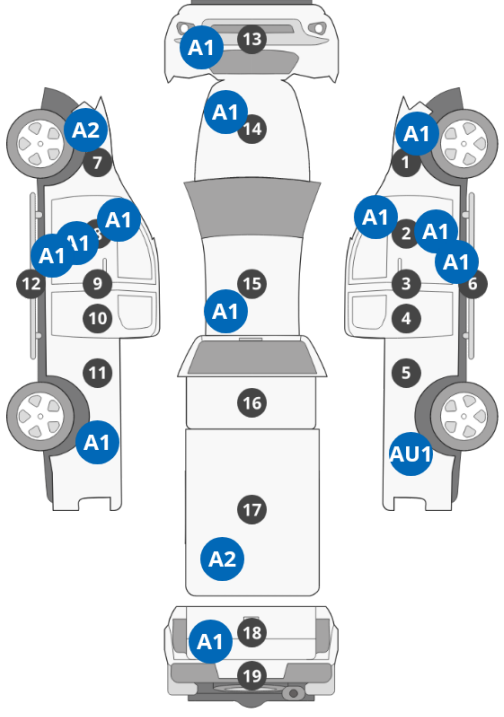
| <div> <div>Interior Evaluation :</div> <div>B</div> </div> | <div> <div>Exterior Evaluation :</div> <div>B</div> </div> |
| <div> <div>Remarks</div> <div>Dashboard - Traces of Adhesive Tape - Yes / (L) Front Floor Mat - Worked - Small / (R) Front Floor Mat - Worked - Small / (L) Front Seat - Grime - Minimal / (R) Front Seat - Grime - Minimal / Ceiling - Grime - Minimal / (L) Front Trim - Worked - Small / (R) Front Trim - Worked - Small</div> </div> | <div> <div>Remarks</div> <div>(R) Front Fender, Molding - Scratch - Minimal / (R) Mirror - Scratch - Minimal / (R) Front Door, Molding - Scratch - Minimal / (R) Side Gate - Scratch &amp; Dent - Minimal / Rear Gate - Scratch - Minimal / Cargo Bed Floor - Scratch - Small / (L) Side Gate - Scratch - Minimal / (L) Front Door, Molding - Scratch - Minimal / (L) Mirror - Scratch - Minimal / Roof - Scratch - Minimal / (L) Step, In-panel, Side Spoiler - Scratch - Minimal / (R) Step, In-panel, Side Spoiler - Scratch - Minimal / (L) Front Fender, Molding - Scratch - Small / Bonnet, Headlight - Scratch - Minimal / Front Bumper, Grille, Lamps - Scratch - Minimal</div> </div> |
