## General Information

| Make | Toyota | Model | Vios |
| Registration No. | NHS6373 | Chassis No. | PA1B18F39R4263376 |

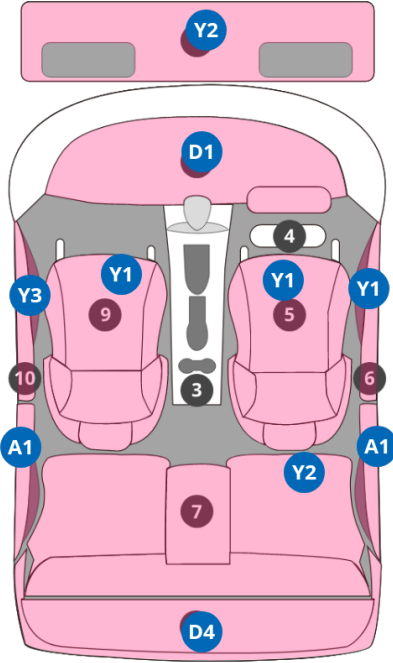
| Interior Evaluation : <b>C</b> | Exterior Evaluation : <b>E</b> |
| <p><b>Remarks</b></p> <p>Ceiling - Grime - Small / Rear Seat - Grime - Small / (R) Rear Trim - Cut, Crack - Minimal / (R) Front Trim - Grime - Minimal / Trunk Room - Loose, Deformed - Large / (L) Rear Trim - Cut, Crack - Minimal / (L) Front Trim - Grime - Medium / (L) Front Seat - Grime - Minimal / Dashboard - Loose, Deformed - Minimal / (R) Front Seat - Grime - Minimal</p> | <p><b>Remarks</b></p> <p>(R) Front Fender, Molding - Scratch - Minimal / (R) Mirror - Scratch - Minimal / (R) Front Door, Molding - Scratch &amp; Dent - Medium / (R) Step, In-panel, Side Spoiler - Scratch &amp; Dent - Large / (R) Rear Door, Molding - Scratch - Large / (R) Rear Fender, Molding - Scratch &amp; Dent - Large / Rear Bumper, Lamps, Panels - Scratch &amp; Dent - Medium / Trunk Hood, Rear Gate - Scratch &amp; Dent - Small / (L) Rear Fender, Molding - Scratch - Minimal / (L) Rear Door, Molding - Scratch &amp; Dent - Small / (L) Front Door, Molding - Scratch &amp; Dent - Minimal / (L) Step, In-panel, Side Spoiler - Scratch - Small / (L) Mirror - Scratch - Minimal / Roof - Scratch - Minimal / (L) Front Fender, Molding - Scratch - Minimal / Front Bumper, Grille, Lamps - Scratch - Large / Bonnet, Headlight - Scratch - Minimal / Member (Bolted) - Dent - Yes</p> |

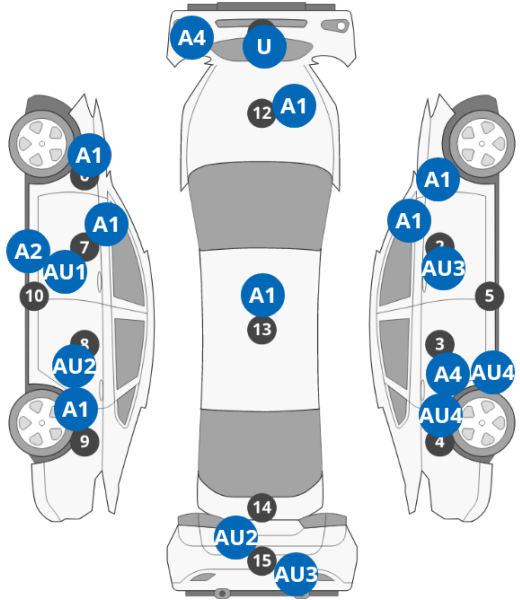
| Inspector Notes |
|---|
| With Lto plate, with spare tire and jack, 3keys, no warranty booklet and tools ,scratches on headlights and taillights , right fender light issue, abnormal vibration on engine, worn tires |
