## General Information

| Make | Toyota | Model | Hilux Tamaraw |

## Body / Panel Condition

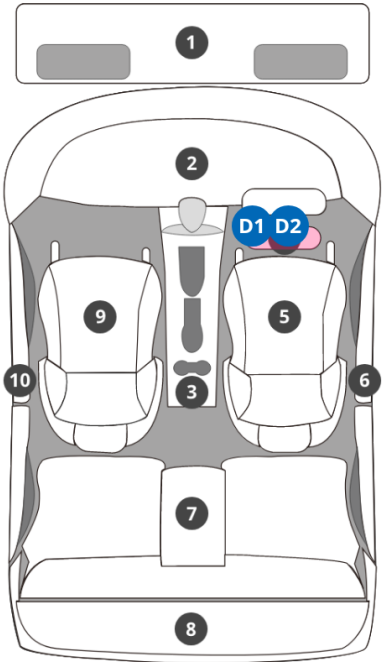
| Interior Evaluation : <span style="color: red; font-weight: bold;">A</span> | Exterior Evaluation : <span style="color: red; font-weight: bold;">D</span> |
| <b>Remarks</b><br>(L) Front Floor Mat - Worked - Small / Carpet - Worked - Minimal | <b>Remarks</b><br>(R) Front Fender, Molding - Scratch - Minimal / (R) Front Door, Molding - Scratch - Minimal / (R) Step, In-panel, Side Spoiler - Scratch - Minimal / (R) Side Gate - Scratch & Dent - Large / Rear Gate - Scratch - Minimal / Rear Bumper, Lamps, Panels - Scratch - Minimal / (L) Side Gate - Scratch - Medium / Roof - Scratch & Dent - Large / (L) Front Door, Molding - Scratch - Minimal / (L) Mirror - Scratch - Minimal / (L) Step, In-panel, Side Spoiler - Scratch - Minimal / (L) Front Fender, Molding - Scratch - Minimal / Front Bumper, Grille, Lamps - Crack, Gap - Large / Bonnet, Headlight - Scratch - Minimal / Cargo Bed Floor - Scratch - Large |

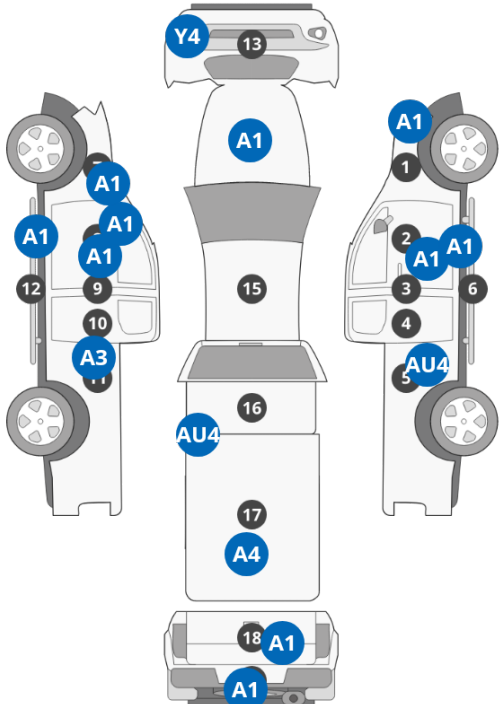
With Lto plate, with spare tire and jack, 2keys, no warranty booklet and tools, scratches on headlights,
