## General Information

| Make | Toyota | Model | Hilux |
| Registration No. | DCC9520 | Chassis No. | MR0DB8CD9S0135281 |

## Body / Panel Condition

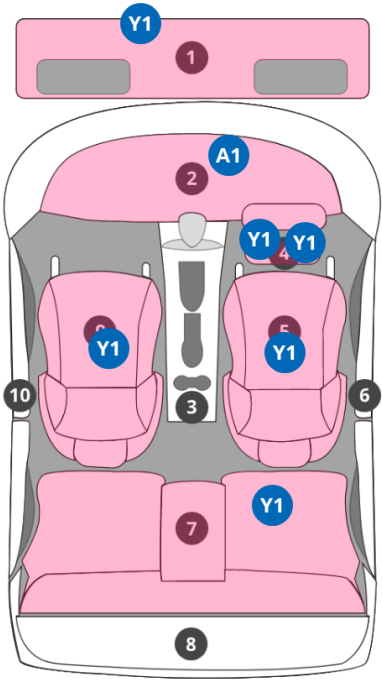
| Interior Evaluation : <b>A</b> | Exterior Evaluation : <b>B</b> |
|---|---|
| <p><b>Remarks</b></p> <p>Rear Seat - Grime - Minimal / (R) Front Seat - Grime - Minimal / (L) Front Seat - Grime - Minimal / (L) Front Floor Mat - Grime - Minimal / (R) Front Floor Mat - Grime - Minimal / Dashboard - Worn, Scratch, Cut, Crack - Minimal / Ceiling - Grime - Minimal</p> | <p><b>Remarks</b></p> <p>(R) Front Fender, Molding - Scratch - Minimal / (R) Front Door, Molding - Scratch - Minimal / (R) Rear Door, Molding - Scratch - Minimal / (R) Step, In-panel, Side Spoiler - Scratch - Minimal / (R) Mirror - Scratch - Minimal / (R) Side Gate - Scratch - Minimal / Cargo Bed Floor - Scratch - Minimal / Rear Gate - Scratch - Minimal / (L) Side Gate - Scratch - Minimal / (L) Rear Door, Molding - Scratch - Minimal / (L) Step, In-panel, Side Spoiler - Scratch - Minimal / (L) Front Door, Molding - Scratch - Minimal / (L) Front Fender, Molding - Scratch - Minimal / Roof - Scratch - Minimal</p> |

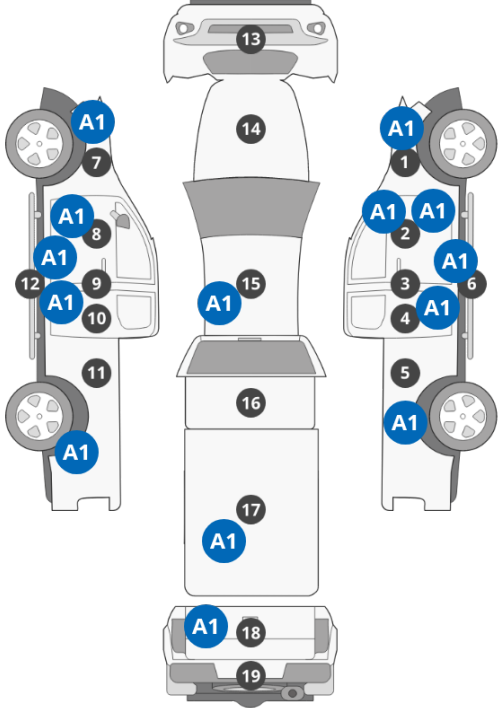
| Inspector Notes |
|---|
| without lto plate/with jack no tools/without reverse camera/with warranty booklet/with hairlines scratches on the body/with spare key/modified power window |
