## General Information

| Make | Toyota | Model | Hilux Tamaraw |
| YOM | 2025 | Odo Meter Reading | 51,828 |
| Registration No. | NKP9541 | Chassis No. | PAHACACA7S6424166 |

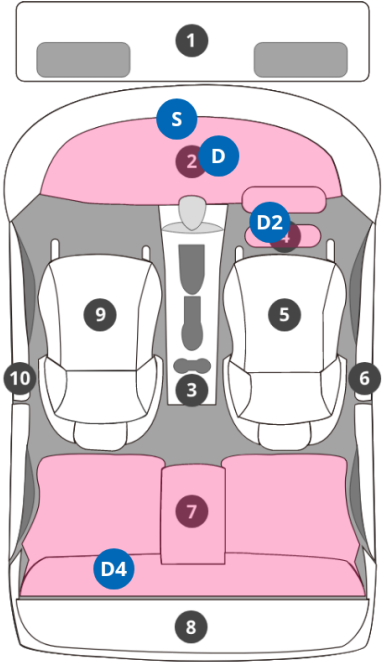
| Interior Evaluation : <b>C</b> | Exterior Evaluation : <b>E</b> |
|---|---|
| <p><b>Remarks</b></p> <p>Overall Interior - Smell - Yes / (L) Front Floor Mat - Worked - Small / Dashboard - Traces of Adhesive Tape - Yes / Trim Other - Worked - Large</p> | <p><b>Remarks</b></p> <p>(L) Side Gate - Partially Missing - Yes / Front Bumper, Grille, Lamps - Repair mark - Yes / Front Bumper, Grille, Lamps - Scratch &amp; Dent - Large / (R) Guard Frame - Scratch &amp; Dent - Large / (R) Side Gate - Dent - Small / Rear Bumper, Lamps, Panels - Scratch - Large / Rear Gate - Scratch - Small / (L) Side Gate - Scratch - Medium / (L) Front Door, Molding - Dent - Small / (R) Front Door, Molding - Scratch - Small / Cargo Bed Floor - Scratch &amp; Dent - Large</p> |

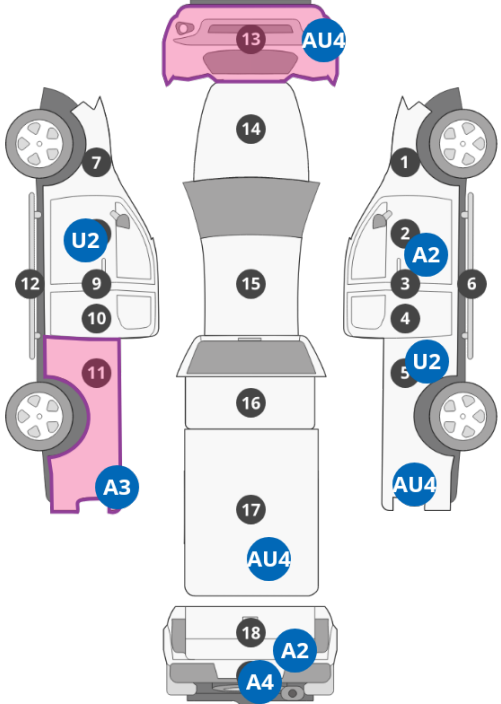
| Inspector Notes |
|---|
| possible flooding/ rear door cannot be opened/ missing fuell lid cover/ light scratches around the exterior/ no jack and tools/ no warranty booklet/ with spare tire and LTO plate |
