## General Information

| Make | Toyota | Model | Vios |
| YOM | 2024 | Odo Meter Reading | 46,172 |
| Registration No. | CCF4008 | Chassis No. | PA1B18F38R426J358 |

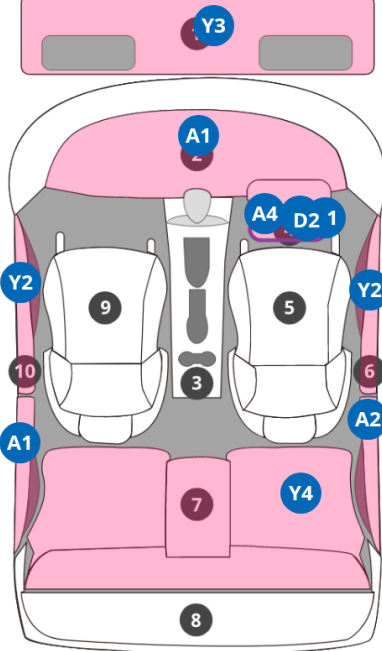
| Interior Evaluation : <span style="color: red;">C</span> | Exterior Evaluation : <span style="color: red;">C</span> |
|---|---|
| <p><b>Remarks</b></p> <p>Ceiling - Grime - Medium / Rear Seat - Grime - Large / Mat Other - Missing - Yes / (L) Front Trim - Grime - Small / (L) Front Floor Mat - Cut, Crack - Large / Carpet - Worked - Minimal / (R) Rear Trim - Cut, Crack - Small / (R) Front Trim - Grime - Small / (R) Front Floor Mat - Worked - Small / Dashboard - Worn, Scratch, Cut, Crack - Minimal / (L) Rear Trim - Cut, Crack - Minimal</p> | <p><b>Remarks</b></p> <p>(L) Front Fender - Repair Traces - Yes / (R) Front Fender, Molding - Scratch &amp; Dent - Small / (R) Mirror - Scratch - Minimal / (R) Front Door, Molding - Scratch &amp; Dent - Small / (R) Step, In-panel, Side Spoiler - Scratch - Small / (R) Rear Door, Molding - Scratch &amp; Dent - Minimal / (R) Rear Fender, Molding - Scratch &amp; Dent - Minimal / Rear Bumper, Lamps, Panels - Scratch &amp; Dent - Small / Trunk Hood, Rear Gate - Scratch &amp; Dent - Minimal / (L) Rear Fender, Molding - Scratch &amp; Dent - Small / (L) Rear Door, Molding - Scratch - Minimal / (L) Front Door, Molding - Scratch - Minimal / (L) Mirror - Scratch - Minimal / (L) Step, In-panel, Side Spoiler - Scratch - Small / (L) Front Fender, Molding - Scratch - Minimal / Member (Bolted) - Dent - Yes / Front Bumper, Grille, Lamps - Scratch &amp; Dent - Small / Bonnet, Headlight - Scratch - Minimal / Roof - Scratch - Minimal</p> |

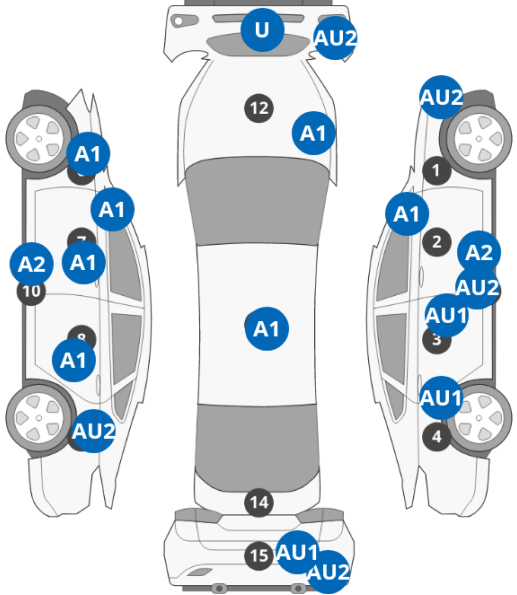
| Inspector Notes |
|---|
| With Lto plate, with spare tire and jack, with warranty, 2keys, no tools, scratches on headlights and taillights, possible flooding, left fender light issue |
