## General Information

| Make | Toyota | Model | Hilux Tamaraw |
| Registration No. | CCQ5232 | Chassis No. | PAHACACA5S64327833 |

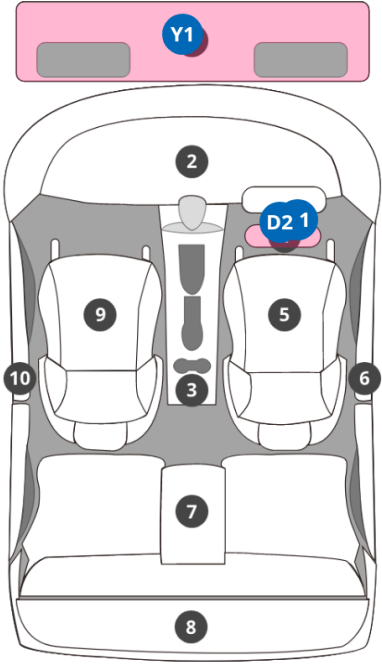
| Interior Evaluation : <span style="color: red; font-weight: bold;">A</span> | Exterior Evaluation : <span style="color: red; font-weight: bold;">C</span> |
| <b>Remarks</b><br>Carpet - Worked - Minimal / (L) Front Floor Mat - Worked - Small / Ceiling - Grime - Minimal | <b>Remarks</b><br>(R) Front Fender, Molding - Scratch - Minimal / (R) Mirror - Scratch - Minimal / (R) Front Door, Molding - Scratch - Minimal / (R) Step, In-panel, Side Spoiler - Scratch - Minimal / (R) Side Gate - Scratch - Small / Rear Bumper, Lamps, Panels - Dent - Medium / Rear Gate - Scratch - Minimal / Cargo Bed Floor - Scratch - Large / (L) Side Gate - Scratch - Minimal / Roof - Scratch & Dent - Medium / (L) Front Door, Molding - Scratch - Minimal / (L) Step, In-panel, Side Spoiler - Scratch - Minimal / (L) Mirror - Scratch - Minimal / (L) Front Fender, Molding - Scratch - Minimal / Front Bumper, Grille, Lamps - Scratch - Small / Bonnet, Headlight - Scratch - Minimal |

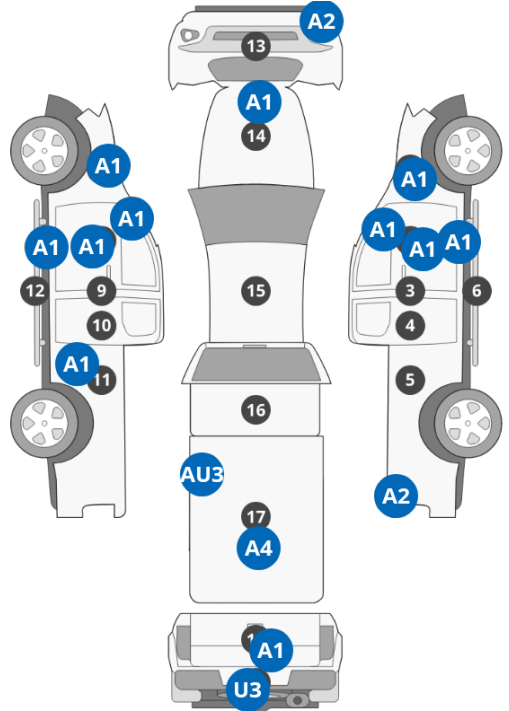
With Lto plate, with spare tire, with warranty booklet, 2keys, no jack and tools, scratches on headlights
