## General Information

| Make | Toyota | Model | Hilux Tamaraw |
| Registration No. | CCQ7085 | Chassis No. | PAHACACA0S6431823 |

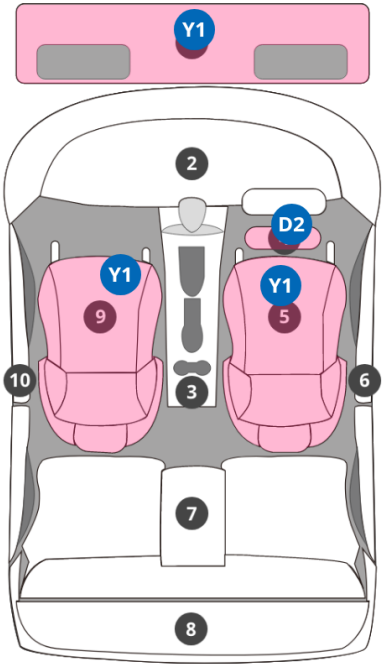
| Interior Evaluation : <b>A</b> | Exterior Evaluation : <b>C</b> |
| <p><b>Remarks</b><br/>Ceiling - Grime - Minimal / (L) Front Seat - Grime - Minimal / (R) Front Seat - Grime - Minimal / (L) Front Floor Mat - Worked - Small</p> | <p><b>Remarks</b><br/>(R) Front Fender, Molding - Scratch - Minimal / (R) Front Door, Molding - Scratch - Minimal / (R) Step, In-panel, Side Spoiler - Scratch - Minimal / Roof - Scratch - Small / (R) Side Gate - Scratch - Minimal / Rear Gate - Scratch - Minimal / Cargo Bed Floor - Scratch - Medium / Rear Bumper, Lamps, Panels - Scratch - Minimal / (L) Side Gate - Scratch &amp; Dent - Large / (L) Front Door, Molding - Scratch &amp; Dent - Medium / (L) Front Fender, Molding - Scratch - Minimal / Front Bumper, Grille, Lamps - Scratch - Minimal / (L) Step, In-panel, Side Spoiler - Scratch - Minimal</p> |
